## **RECORD OF INVESTIGATION INTO DEATH**

Ref: 28/17

I, Sarah Helen Linton, Coroner, having investigated the death of **Murray Allan TURNER** and the suspected deaths of **Mason Laurence CARTER** and **Chad Alan FAIRLEY** with an inquest held at the **Perth Coroner's Court, Court 51, CLC Building, 501 Hay Street, Perth**, on **24 to 28 July 2017** find that:

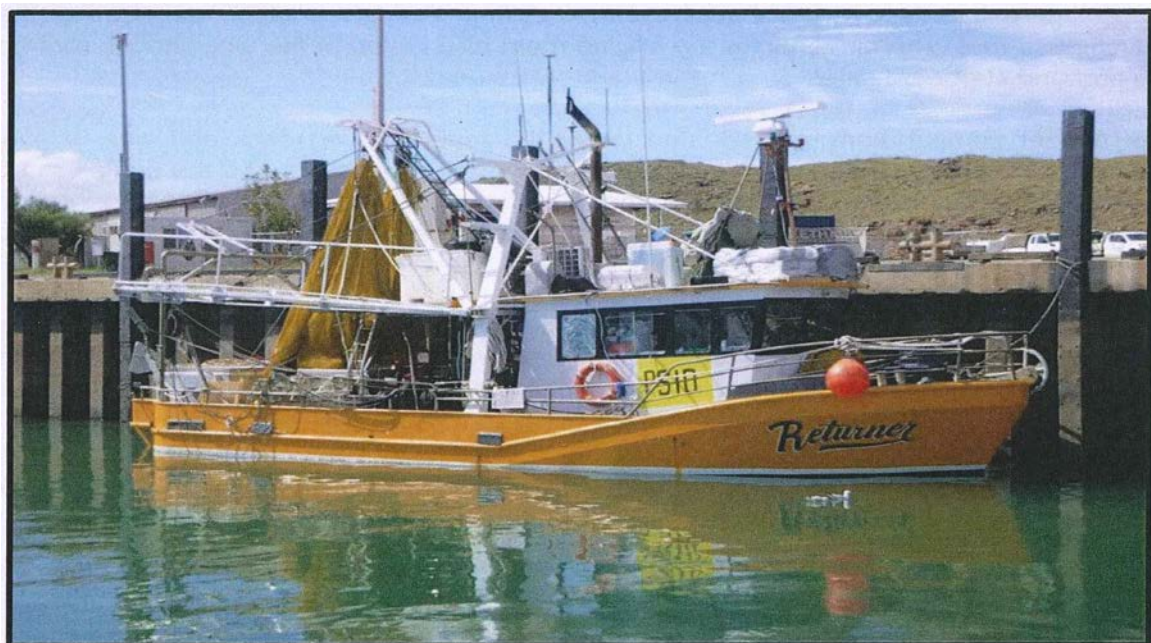
Photo 2 –Vessel after modifications in April 2015

41. The police investigation found no evidence to suggest the modifications or work undertaken on the *Returner* was inferior or of poor quality.<sup>44</sup> However, there was evidence that the overall effect of these extensive modifications

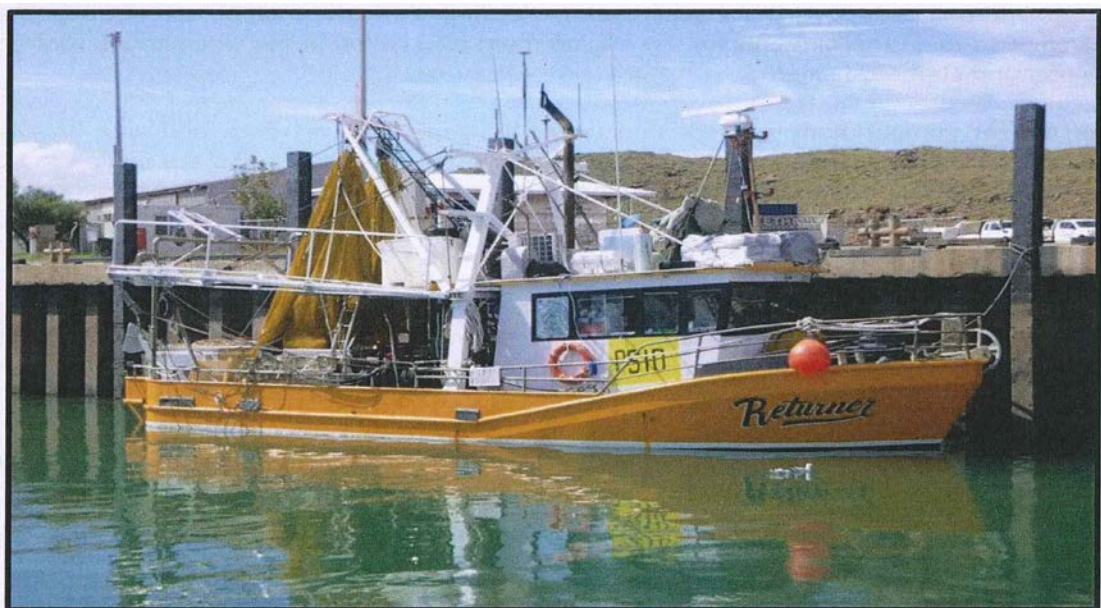
Photo 3 –Vessel after modifications in April 2015

shows the vessel to be marginally deeper in the water than she was at the time of Mr Wren's final inspection on 14 April 2015 in Geraldton.<sup>140</sup>

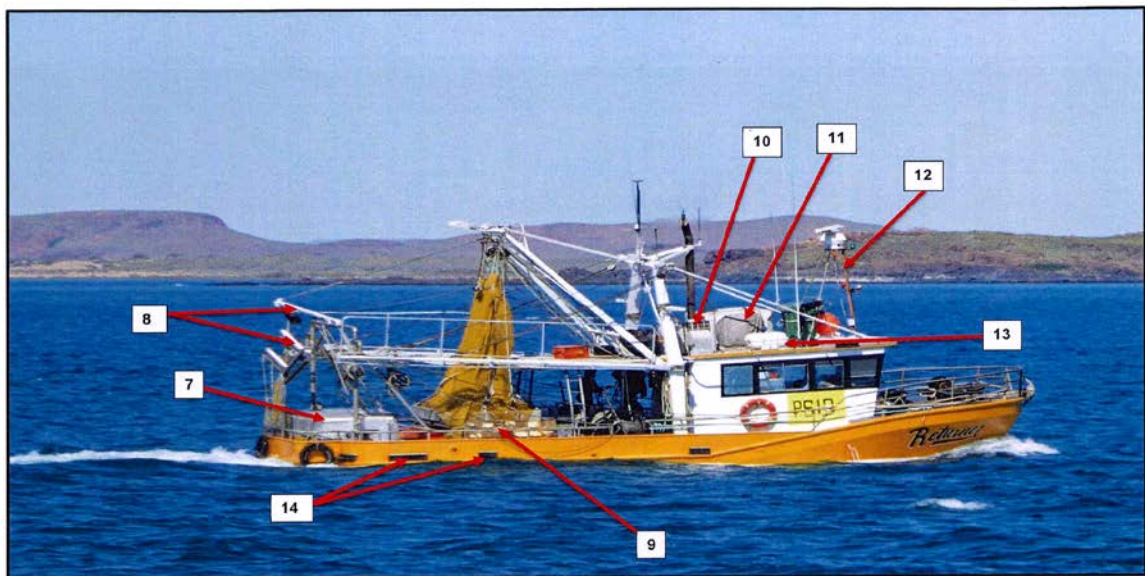
Photo 4 - Returner on Voyage Post 2014/2015 Modifications

108. A further photograph, which is depicted below, caused Mr Wren greater concern. Mr Wren's evidence was that the vessel depicted in that photograph "is very different to the vessel that [he] observed at survey" and in his opinion that photograph shows the vessel "to be grossly overloaded." This is

*With or without reference to any stability book, the vessel in the photograph shows to be clearly unsafe and should not be operating in this way, with almost zero freeboard and the freeing ports covered. If presented to me in any way to this extreme, I would have had no hesitation in refusing completion of the survey until further extensive investigation into the displacement and stability of the vessel was satisfactorily completed. At the very least, this would include a full, new stability assessment and approval process. Being so extreme, the vessel would not in any way have been authorised to operate.*

1. Try net winch situated on aft of wheelhouse roof aft on centreline
2. Large box thought to be containing nets and chain situated on port side on wheelhouse roof (not found at time of salvage)
3. Two wheelie bins thought to be for garbage (not found at time of salvage)
4. Steel exhaust stack thought to be increased in height between 2014 and 2015
5. 30 horsepower outboard motor tied in rigging
6. Large nets increased in size from original vessel
7. 3000 litre brine tank, double the capacity of the original brine tank
8. Try-net rigging thought to be installed between 2014 and 2015
9. Four Otter boards, each weighing approximately 265 kilograms
10. Split system air-conditioning outdoor unit
11. Washing machine (not found at time of salvage)
12. Radar mast moved forward from original 1985 configuration.
13. Liferaft weighing approximately 30 kilograms
14. Covered freeing ports

113. Also, Mr Wren's evidence was that at no stage during inspection of the vessel did he see the freeing ports covered, which he would definitely have noted when he was when looking at the freeboard through the apertures. Mr Wren's evidence was that if he had seen the freeing ports covered in that way, he would have added it as a deficiency to be rectified as he would be concerned that water on deck would be severely restricted from freeing itself overboard.<sup>149</sup>

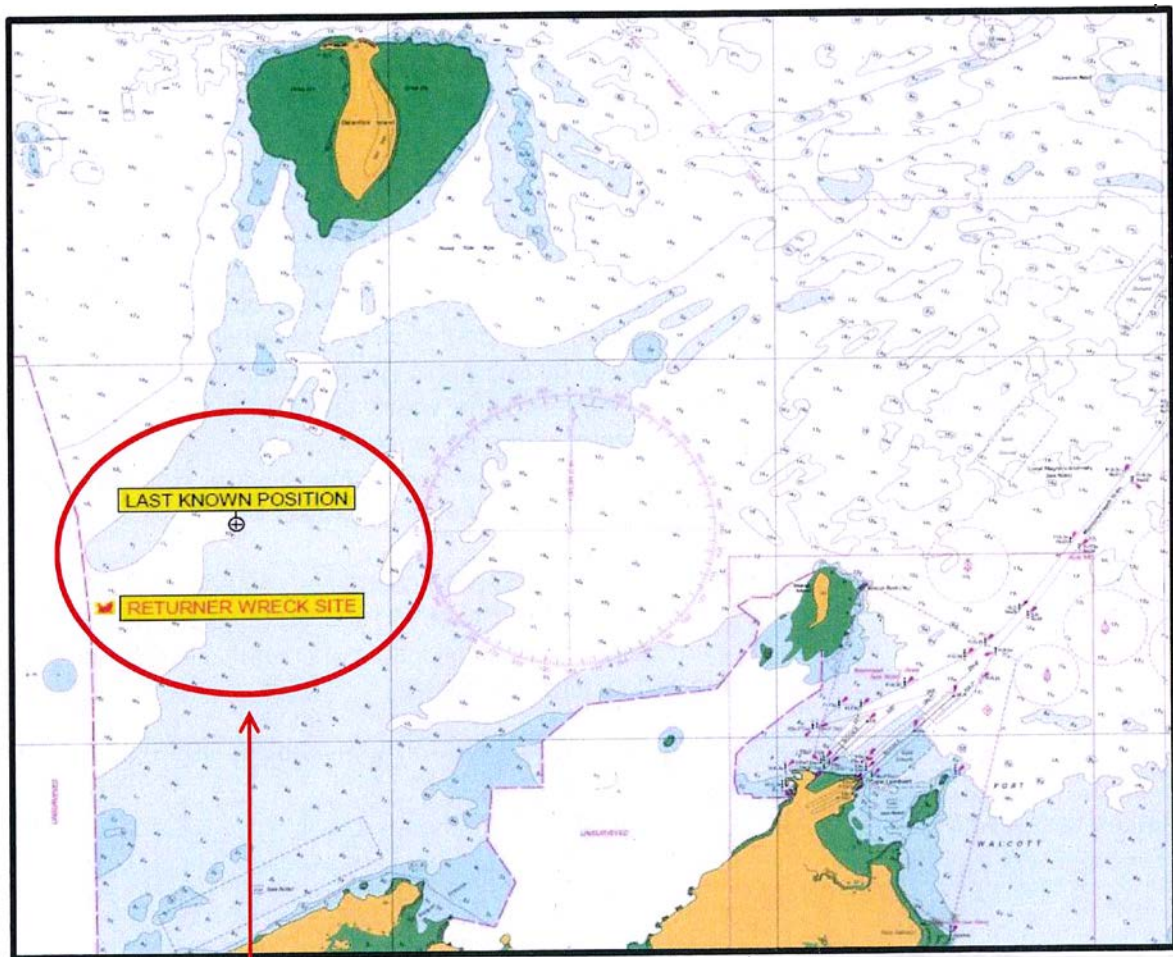
FIGURE 1 FROM REPORT IN Exhibit 1, Tab 11, p. 8

216. On Wednesday, 29 July 2015 the police vessel the *Delphinus* captured an image two kilometres south of the last known ALC coordinates of the *Returner*. The image was identified as the missing vessel *Returner*. The vessel was submerged in approximately 10 metres of water 20 km from Nickol Bay, Karratha.<sup>300</sup> The vessel was found approximately 1.9 nautical miles, or approximately 3.5 kilometres, from its last known position. When depicted on a chart, it can be seen that the vessel sank very close to its last known position.<sup>301</sup>
