RECORD OF INVESTIGATION INTO DEATH

Ref: 03/15

*I, Sarah Helen Linton, Coroner, having investigated the suspected death of **Samuel Eya LEOPOLDO** with an inquest held at the **Perth Coroner's Court, Court 51, CLC Building, 501 Hay Street, Perth, on 23 January 2015** find that the death of **Samuel Eya LEOPOLDO** has been established beyond all reasonable doubt, that the identity of the deceased person was **Samuel Eya LEOPOLDO** and that death occurred on or about **17 November 2011 in sea, approximately three nautical miles west of Rottnest Island off the port of Fremantle, Western Australia (Latitude 32° 00.85' South, Longitude 115° 23.95' East)** in the following circumstances -*

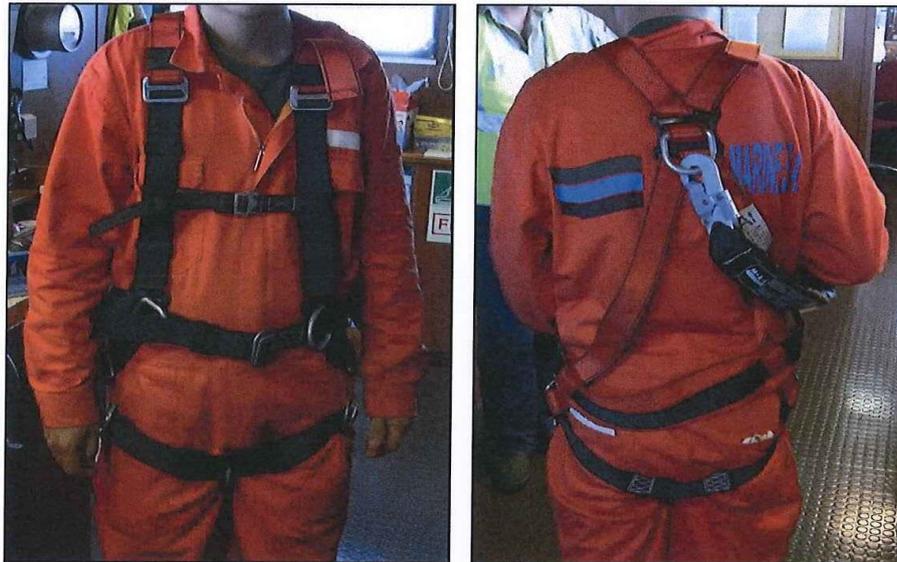
Figure 3: The same type of safety harness as used on 17 November (front and back)

Figure 3 - Harness Type Worn by the Deceased

45. The empty harness was pulled back up by the ship's crew and the bosun observed that the rope was still intact and attached to the harness but the buckle securing the strap across the chest was unlocked.⁶² The safety harness was later seized by police. It was still attached to the safety line and visual examination of the harness did not reveal any damage to the straps or buckles, nor any fault with the harness.⁶³ However, it was apparent that the chest buckle and the right leg buckle, two of its four buckles, were undone.⁶⁴

46. The ATSB investigator, Captain Chaudhri, noted that the only explanation for the undone buckles is that either they had not been done up or Mr Leopoldo undid them to avoid being pounded by the ship's side. If they were undone by Mr Leopoldo, which is unlikely because it is difficult to undo a buckle once it has weight on it, given that he appeared injured and possibly unconscious, loss of muscle tone would have made slipping out of the partially undone harness more likely.⁶⁵
47. After being notified of the man overboard, the Master began manoeuvring the ship to do a turn. Additional crew were posted as look-outs and a further life ring with a smoke signal was thrown overboard.⁶⁶ A Mayday report was also made over the radio.

66. Senior Constable Jennings also noted that the evidence suggested the life jacket may not have been worn and the safety harness may not have been worn correctly, given a visual examination did not indicate there was any critical damage that would cause it to fail, if worn correctly.⁹²

76. Captain Chaudhri also observed that the tethering equipment used in this case did not include a fall arrestor, and the tethering rope was unnecessarily long, which led to Mr Leopoldo being left hanging under the platform and much closer to the water than was desirable.¹⁰⁵ A proper risk assessment, completed as part of the work permit system, might have established an appropriate rope length and included the use of a fall arrestor.¹⁰⁶
