RECORD OF INVESTIGATION INTO DEATH

Ref No: 27/15

I, Evelyn Felicia Vicker, Deputy State Coroner, having investigated the death of Mr TOBY, with an Inquest held at Kununurra Courthouse, Coolibah Drive, Kununurra, on 11-13 August 2015 find the identity of the deceased was Mr TOBY and that death occurred on 25 August 2012 at Weaber Plain Road, Approximately 27 Kilometres North of Kununurra Town Site, as a result of Head Injury in the following circumstances:

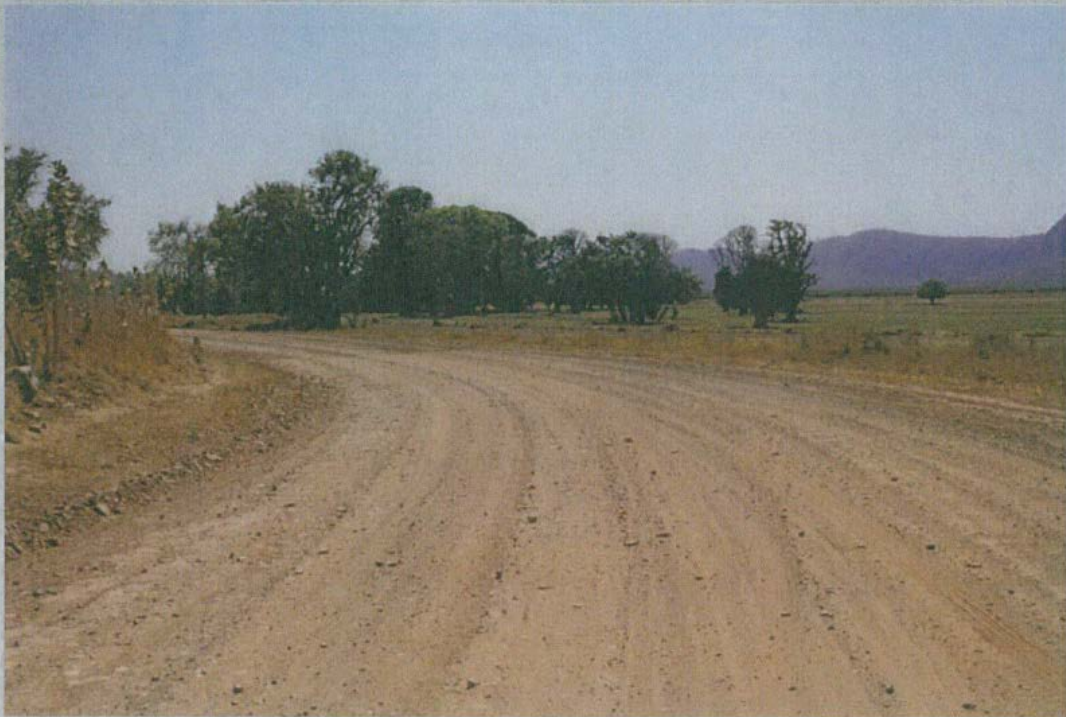
10.0 APPENDIX 1

Weaber Plain Road looking north towards the left hand bend

point of travelling around the relevant left hand curve the Hilux entered an anticlockwise yaw across to the eastern side of the carriage way. As the result of steering input, that is driver input, the Hilux continued to rotate around its vertical axis, back towards the left hand side of the carriageway.

Near the centre of the carriageway the Hilux tipped and rolled over onto its left side where it stopped. The close proximity of the Hilux to the end of the tyre marks on the carriageway surface suggests it only completed a 270° (three quarter) lateral roll.

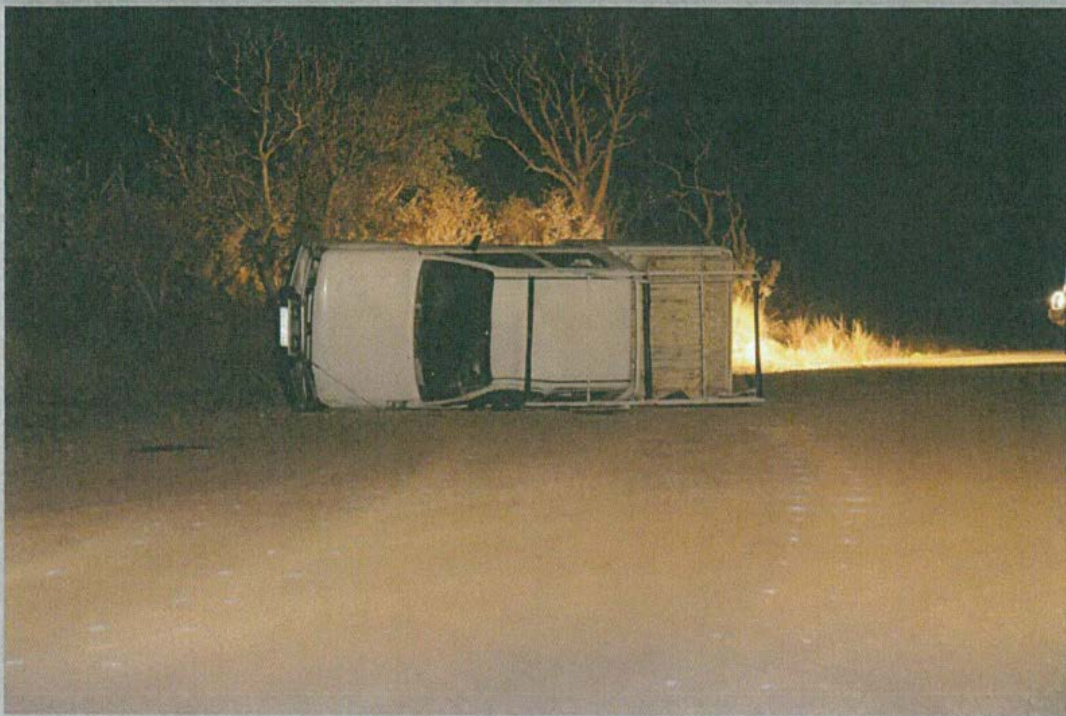
12.0 APPENDIX 3

Examination of both the Hilux and EK 103 conducted by the motor vehicle examiners detected no defects with either vehicle which could have contributed to the crash. All damage to the Hilux was consistent with it having been involved in a slow, three quarter, rollover. It had landed on the passenger side and Mr Toby had been trapped under the vehicle when ejected through the open windows. Examination of the Hilux driver's side seatbelt indicated it was retracted at the time of the rollover indicating it was unlikely Mr Toby had been wearing a seatbelt.

The involved Toyota
