## RECORD OF INVESTIGATION INTO DEATH

*Ref No: 33/13*

*I, Dominic Hugh Mulligan, Coroner, having investigated the death of **Barkad Ahmed Muse**, with an Inquest held at Albany Coroners Court on 25 July 2013, and Perth Coroners Court on 29 July & 19 - 23 August 2013, find that the identity of the deceased person was **Barkad Ahmed Muse** and that death occurred on 20 July 2012, at 282 Middleton Road, Centennial Park, Albany, as a result of **Crush Asphyxiation**, in the following circumstances;*

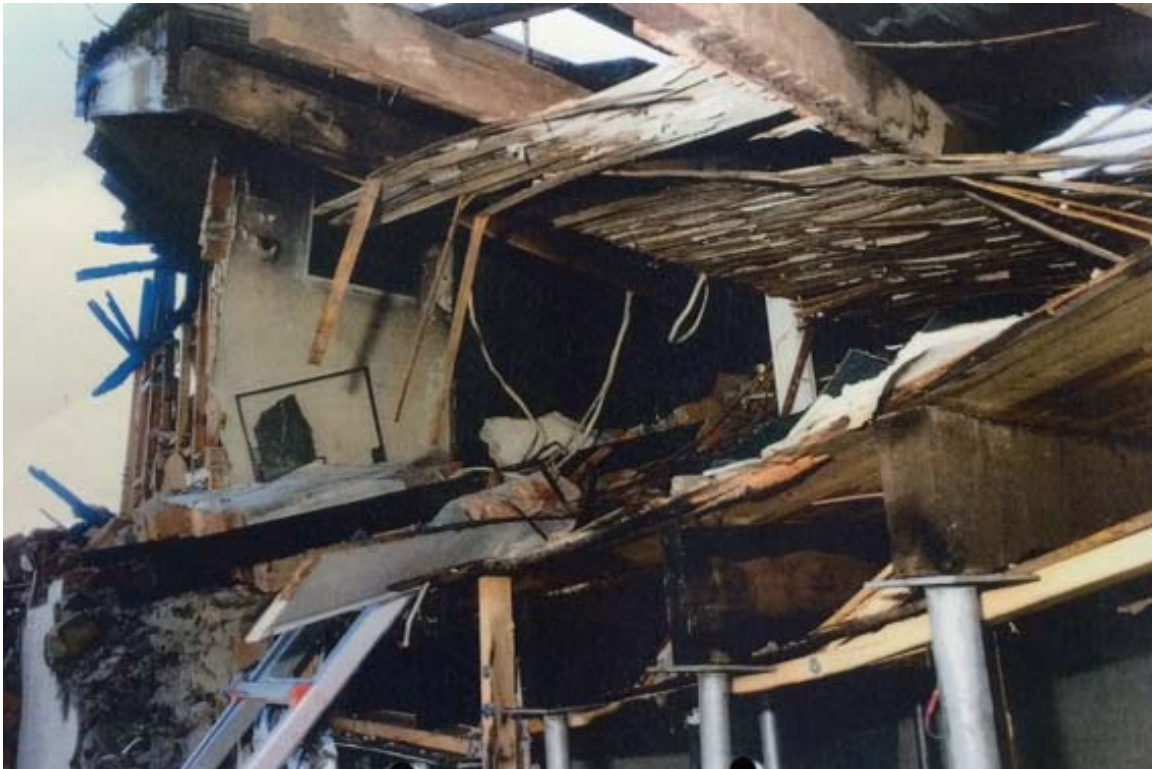
21. The deceased was not so fortunate. He was seated in an arm chair at the time of the explosion. Following the explosion a large part of a brick wall, which formed part of the internal chimney, fell and crushed the deceased as he sat in the chair.

Exhibit 1, Volume 2, Tab 46, Photo 40  
The room in which the deceased died

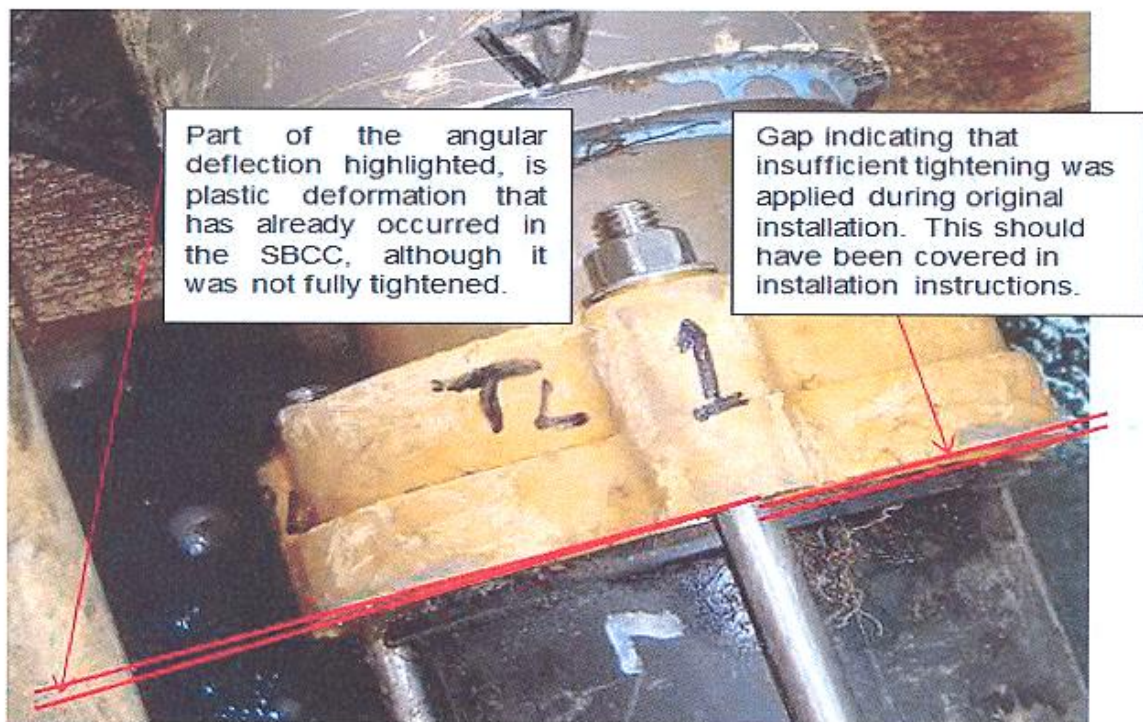
Photograph No 15

50. In about February 1991 a 155mm uPVC gas main was laid along Middleton Road. This included the section in front of 280 and 282 Middleton Road.
51. In about November 1993 an 80mm uPVC gas main was connected to the 155mm gas main in front of 280 Middleton Road. The 80mm uPVC gas main ran from outside 280 Middleton Road and down Douglas Street. Near to the connection of the 80mm gas main to the 155mm gas main a 80mm SBCC was used to connect to 80mm uPVC gas pipes. This SBCC was likely installed in November 1993 when the 80mm gas mains were installed.
52. When the SBCC was first installed in front of 282 Middleton Road it was not tightened to an adequate degree (insufficient torque was applied). The fact the SBCC was not adequately tightened allowed a misalignment of the two pipes entering the SBCC to occur with a total misalignment of approximately 6.4°.

65. At some stage after Mr Bevington and Mr Jones completed their work the SBCC moved a small amount which caused the 6.4° misalignment within the SBCC to grow. As a consequence of that growth in the misalignment a leak developed.

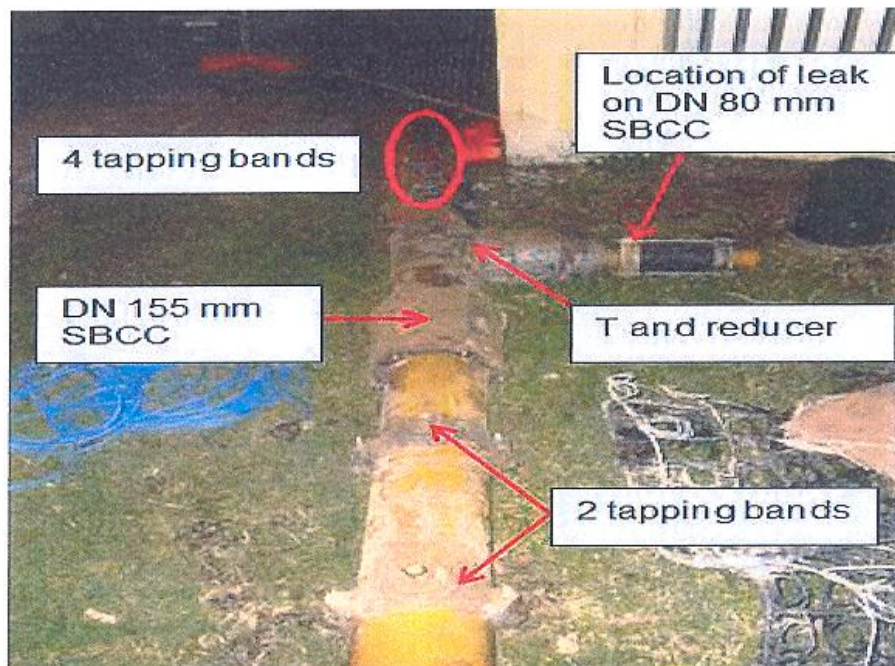
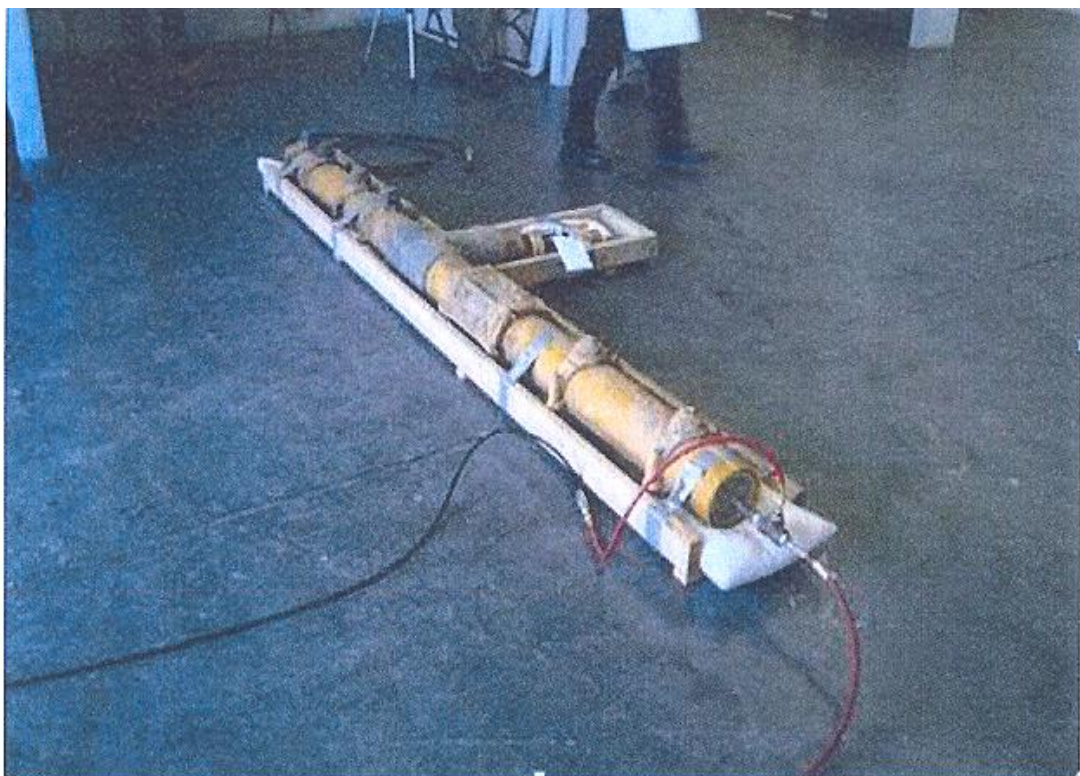
84. Following the explosion at 282 Middleton Road, the Police, EnergySafety and ATCO began investigations in order to try and determine what had led to the explosion.
85. In order to facilitate an adequate examination of the SBCC, it, together with a portion of the 155mm mains was removed from the ground above 280 Middleton Road.

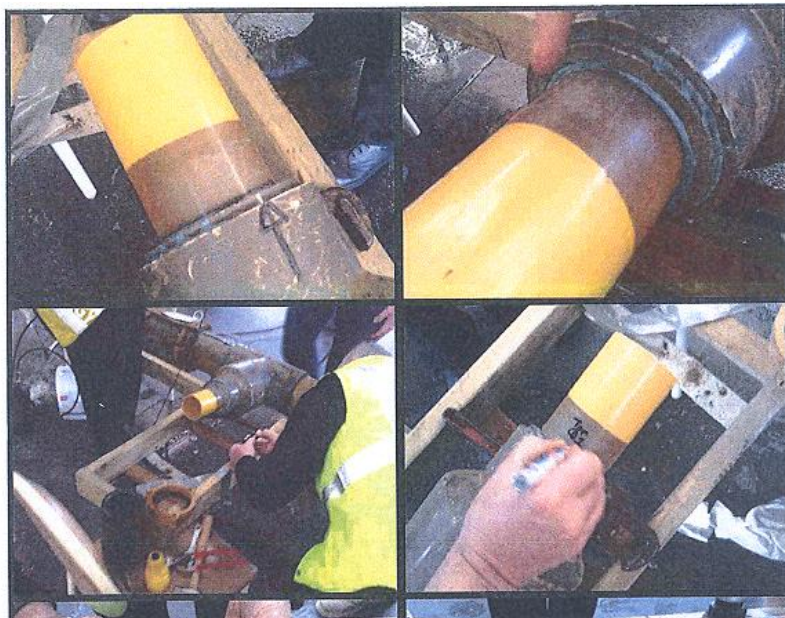
Exhibit 1, Volume 5, Tab 58, Attachment 3c, Page 19

91. They were examined by Mr Dean Solmundson (of ATCO) and Mr Cornelis de Groot, the Principal Engineer, Gas Supply at EnergySafety. They found typical light and dark staining present on the uPVC gas pipe sections along well defined circumferential lines indicating which areas had been exposed to clean gas environment inside the uPVC gas pipe compared to a dirty soil environment on the outside of the coupling. The contact angles between these pipe ends and the subject coupling were calculated from length measurements made using a simple white paper wrap around the pipe as a perpendicular reference line from the lowest edge of the colour line and the measuring offset lengths to the highest edge of the colour line on the opposite side of the pipe.<sup>7</sup>

93. The measurements found that both pipes were off square by approximately 3.2° each with a total angle of misalignment across both pipes of approximately 6.4°.

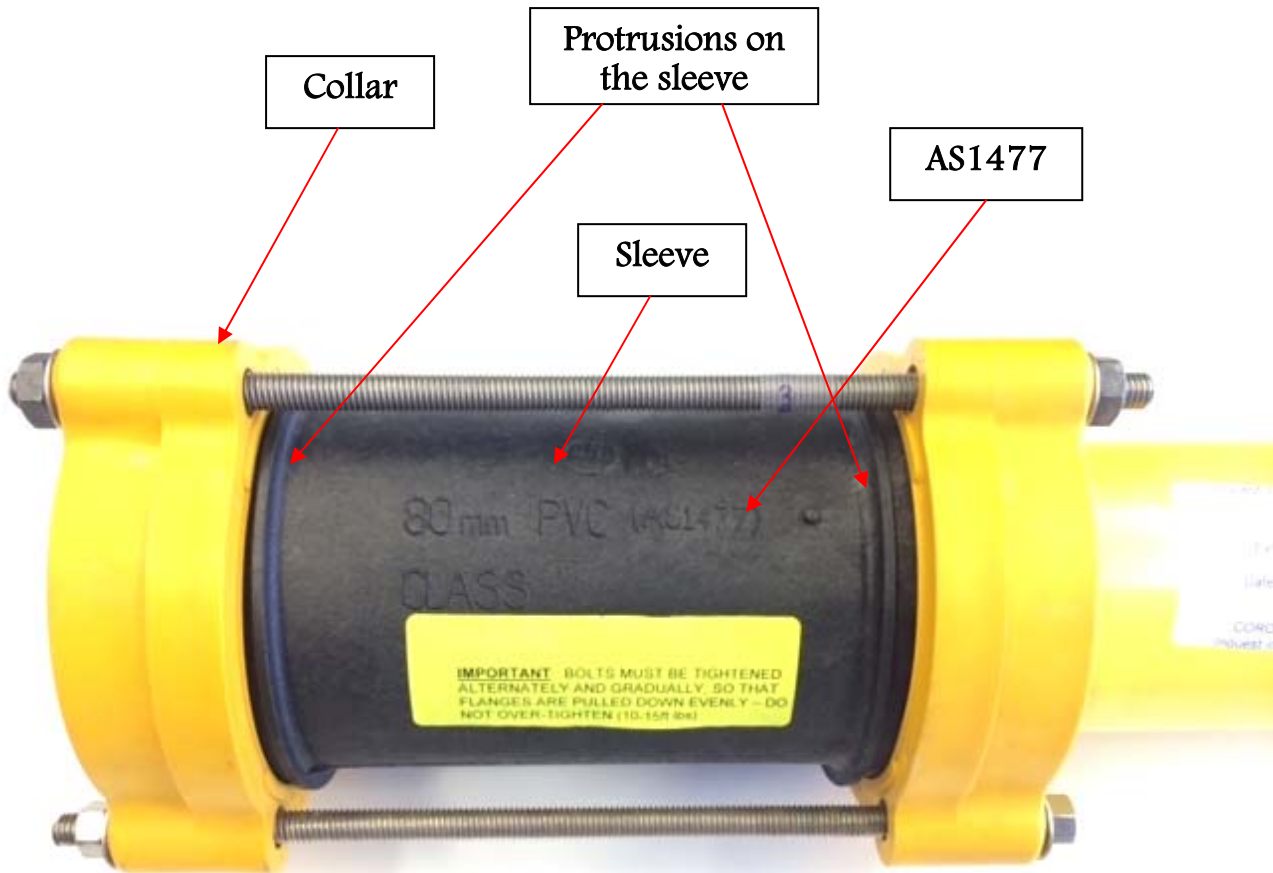
Exhibit 5 – SBBC 80mm coupling with a piece of 80mm uPVC pipe

142. As can be seen from the photograph above the SBCC bares an inscription 'AS1477' which implies the SBCC complies with the stated Australian/New Zealand standard which is now properly described as AS/NZS 1477.

144. After careful analysis EnergySafety found that for eight different reasons<sup>20</sup> the SBCC does not currently comply with AS/NZS 1477, nor has it ever complied with any previous version of AS/NZS 1477. Those reasons include the fact that the SBCC was made from different materials to that required under AS/NZS 1477. In this regard AS/NZS 1477 refers to fittings that are made from PVC. The standard states;
