RECORD OF INVESTIGATION INTO DEATH

Ref No: 19/13

*I, Dominic Hugh Mulligan, Coroner, having investigated the death of **Thomas Michael BRASIER**, with an Inquest held at Perth Coroners Court on 13-17 May 2013 and 28 June 2013, find that the identity of the deceased person was **Thomas Michael BRASIER** and that death occurred on 27 October 2009, at Sir Charles Gairdner Hospital, Nedlands, the cause of death being **Consistent with Multiple Injuries**, in the following circumstances;*

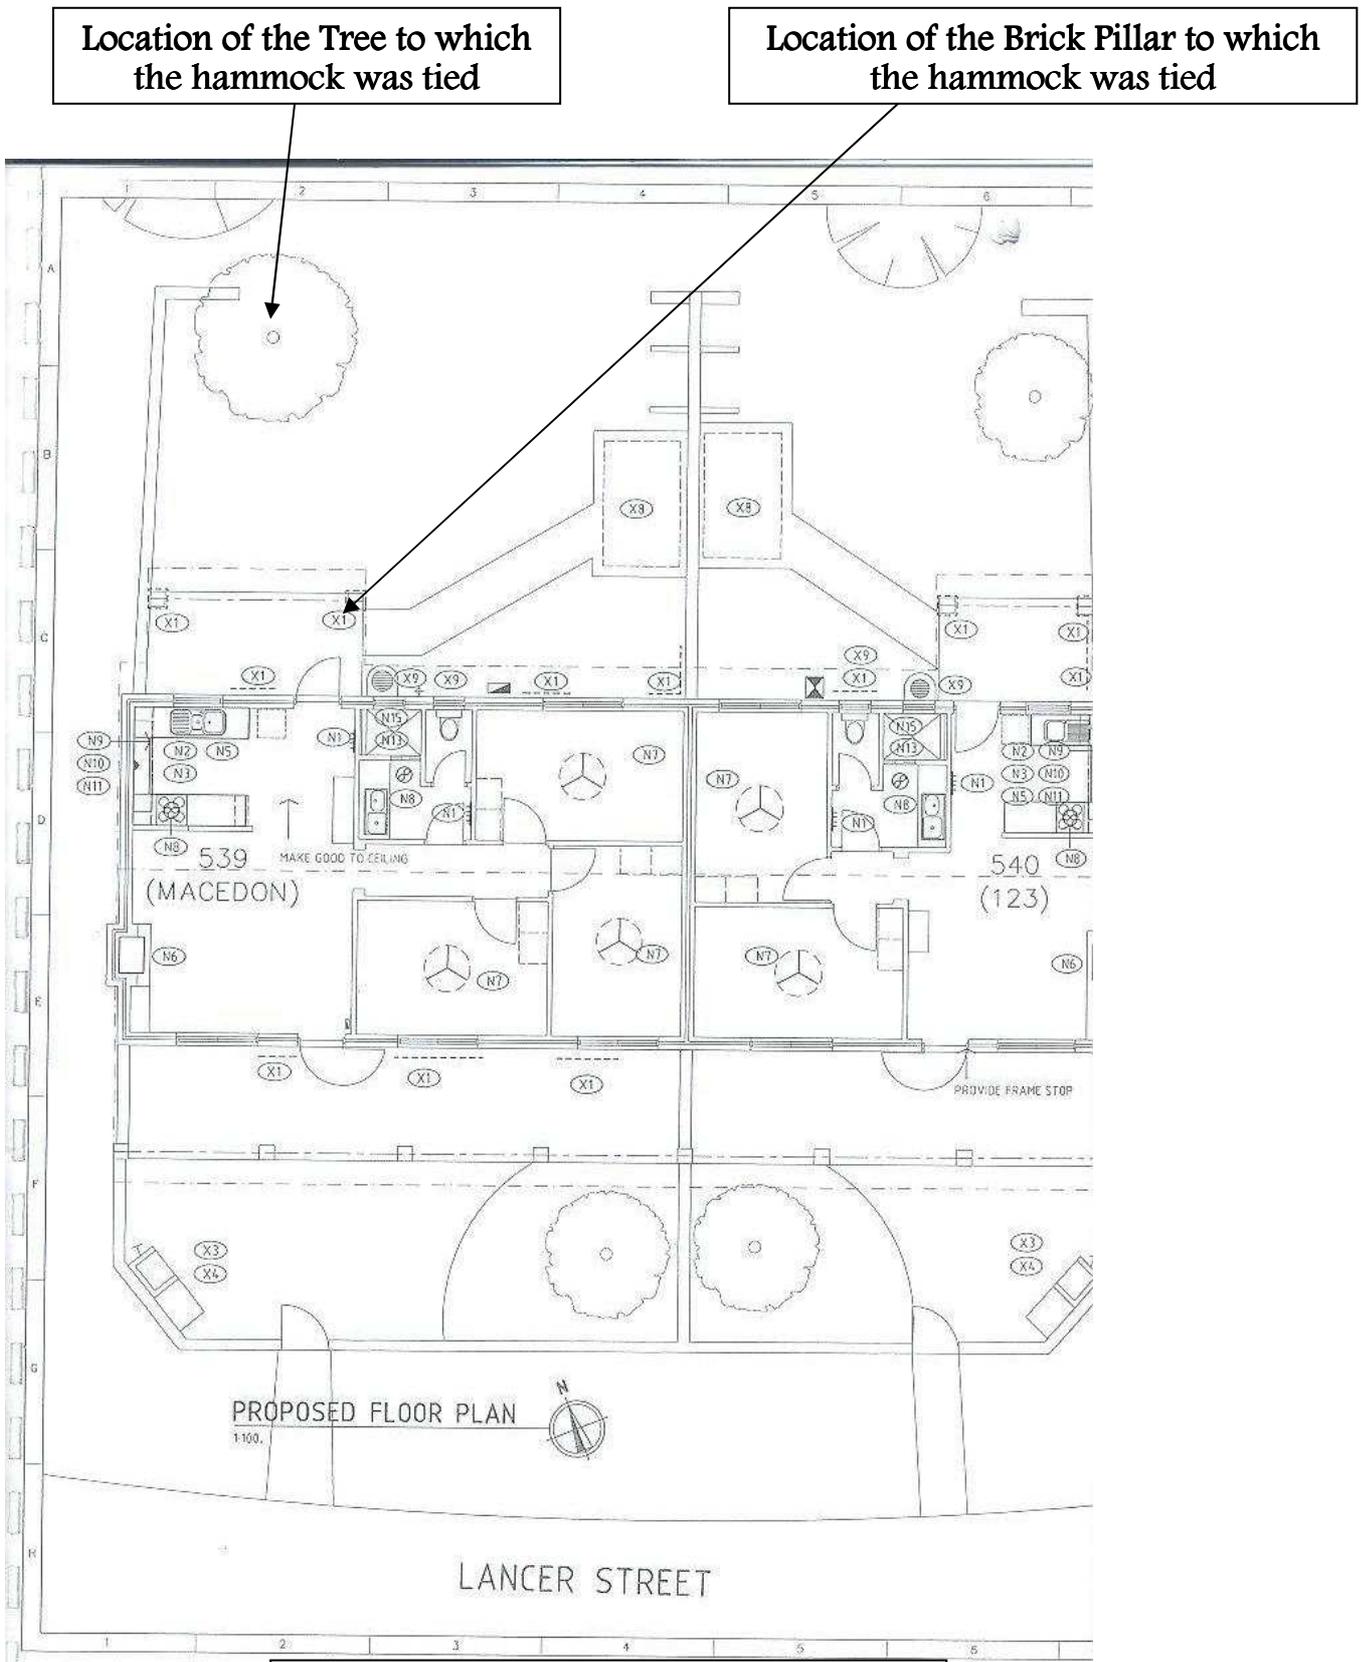
Exhibit 4, Volume 2, Tab 26, Drawing Number A.24.02

12. The masonry pillar was approximately 2300mm x 310mm x 320mm. It was constructed of bricks and mortar and was very heavy. The top 700mm of the pillar was hollow.
13. The pillar was meant to have been constructed in accordance with an architect's design, which would have seen the pillar tied to the veranda roof by means of a rod, secured at its base by a metal plate built into the fabric of the pillar.
14. The rod was intended to protect through the top of the masonry pillar and through the wooden support beam. The rod was then meant to be bolted on top of the wooden support beam tying the veranda securely to the masonry pillar.

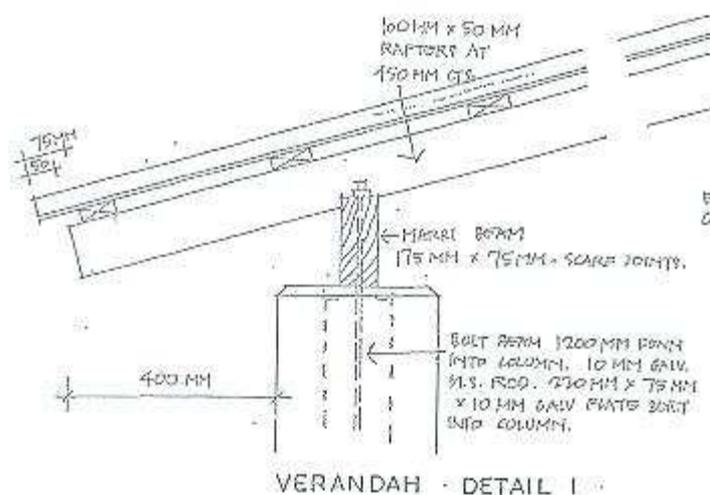
Figure 1 – Exhibit 1 - Mr Ferguson's Design for the Veranda Roof Tie Down

15. The rod was not built into the masonry pillar when it was constructed in 1975. This defect was not detected at the time or during later refurbishments in 1996 and 2006.
16. Had the brick pillar been constructed in the intended manner there would have been little or no risk associated with Mr Daly's decision to use his hammock.
17. Because of the defective construction, the brick pillar was unable to resist lateral forces, such as that placed on it by the loaded hammock.

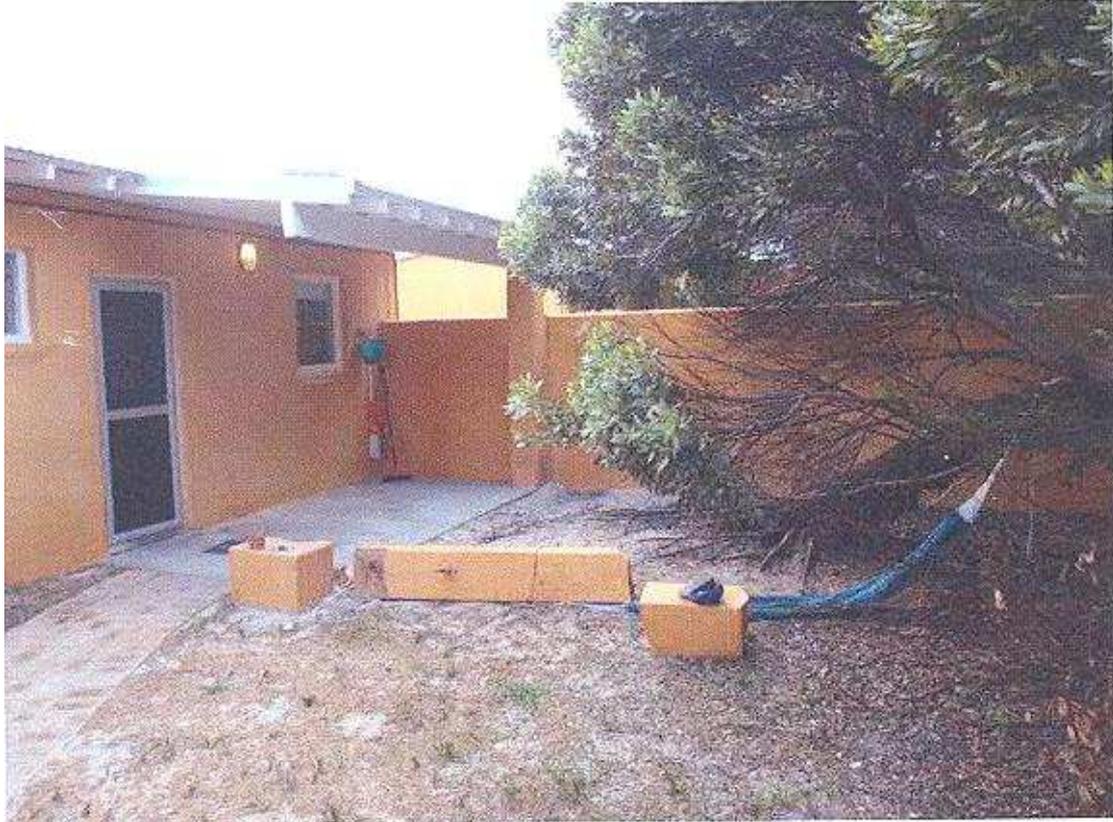
Exhibit 4, Volume 1, Tab 14

29. About 20 to 30 seconds after Thomas got onto the hammock the masonry pillar supporting the hammock failed, broke and fell forward in the direction of the children.
30. The pillar broke into three pieces.

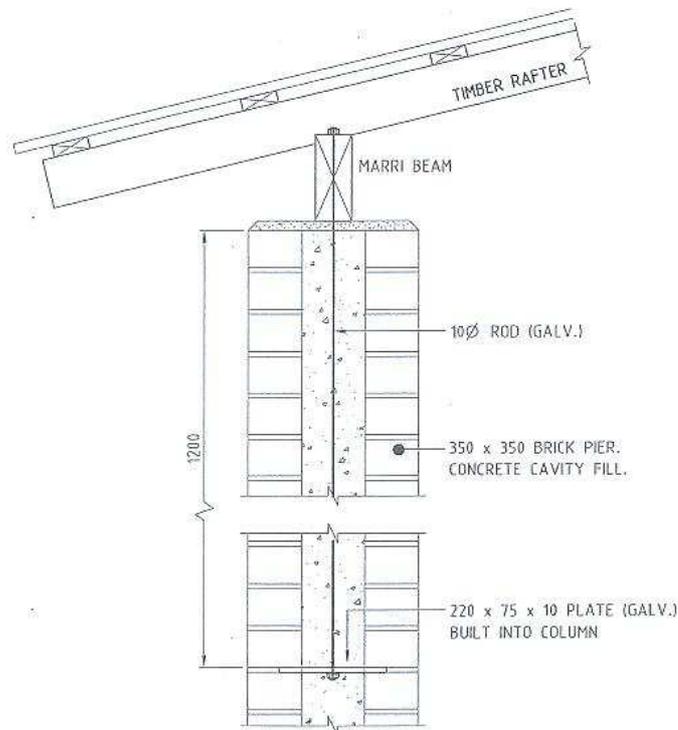
Figure 2 - The manner in which the pillar and tie down should have been constructed ³

75. The roof was to be secured to the masonry pillar by a steel rod which was meant to be welded to a steel plate built into the fabric of the masonry pillar.

76. The galvanised mild steel rod was designed to be 1200mm in length and 10mm in diameter. The galvanised steel rod was meant to be connected to a 10mm thick galvanised steel plate measuring 220mm by 75mm.
77. The galvanised plate was intended to be anchored to the pillar by courses of brick work built over and around it. The hollow centre of the masonry pillar where the rod was located was intended to be filled with concrete. The rod and plate were intended to provide a strong and effective mechanism for securing the porch roof to the brick pillar.
78. As the rod rose above the level of the brick pillar it was intended that it run through a wooden porch support beam. The wooden support beam was an important structural element of the porch roof. A bolt was then to be used to

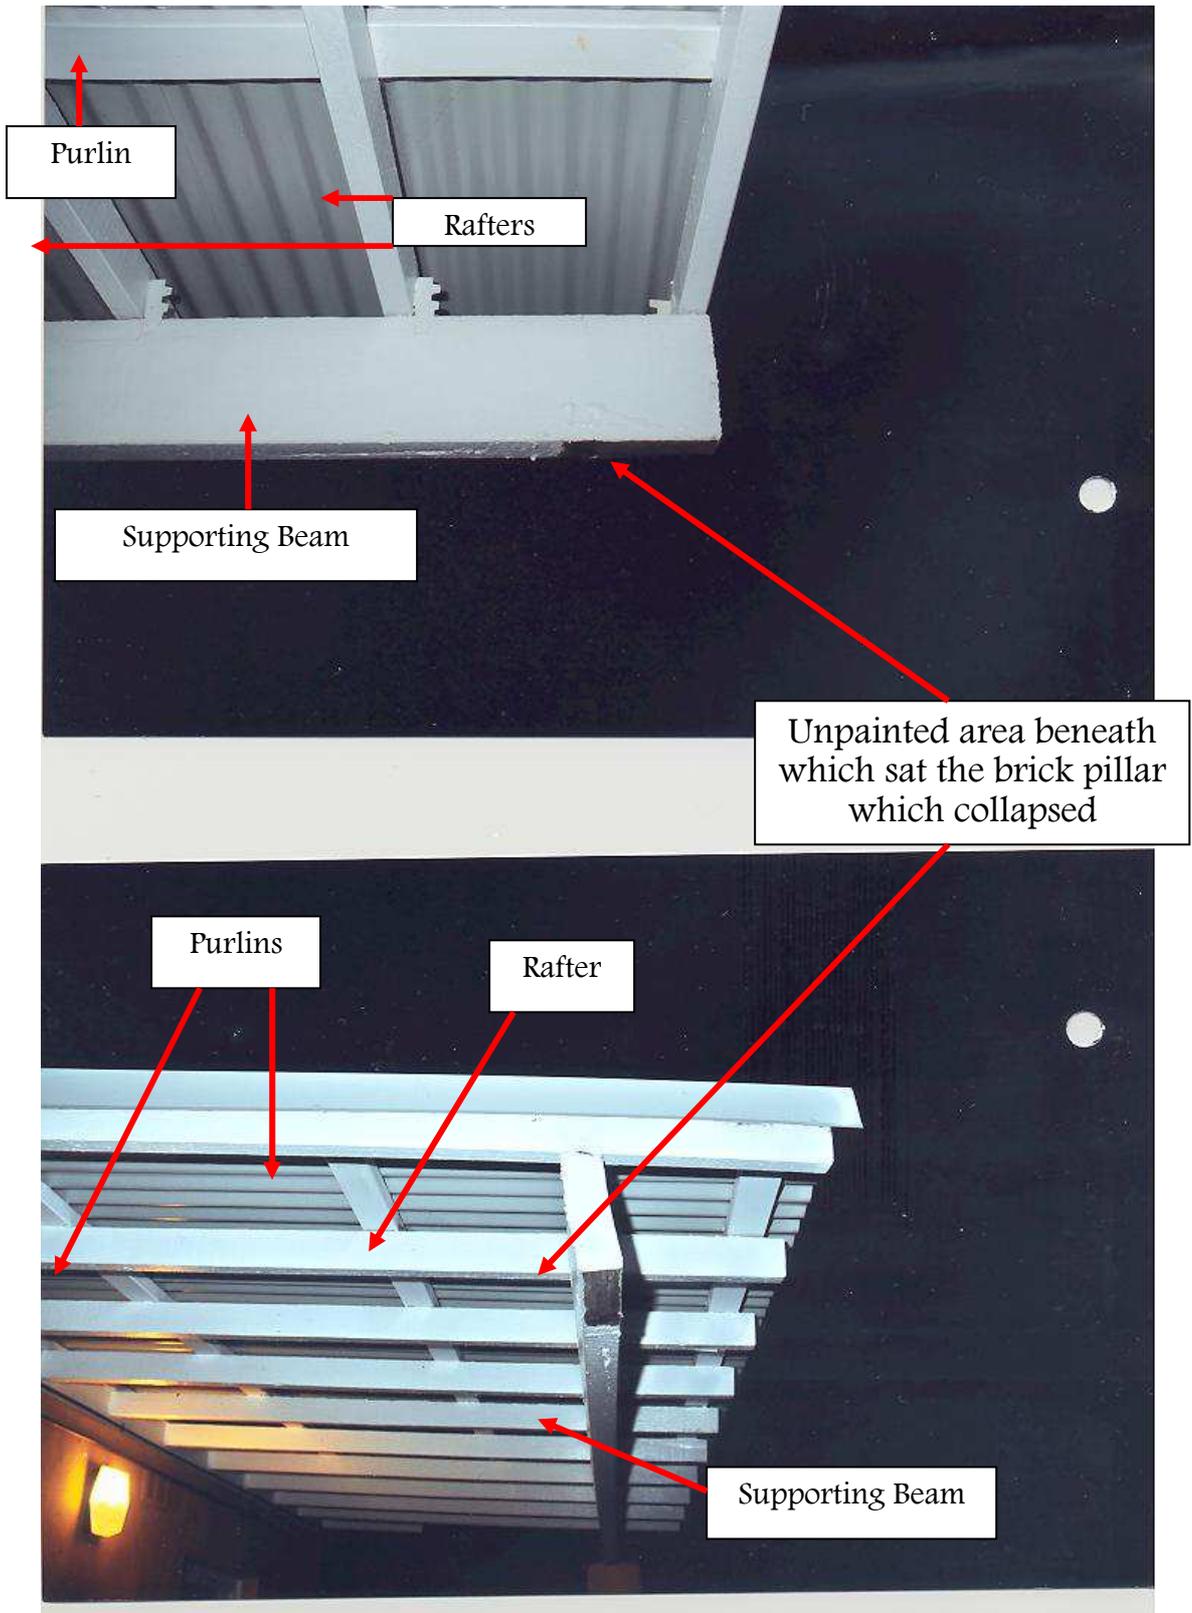
Exhibit 4, Volume 1, Tab 17, Photograph No. 55 & 56 depict the unsupported roof of the veranda/porch of Unit 539
