*Western*

## **RECORD OF INVESTIGATION INTO DEATH**

Ref: 28/17

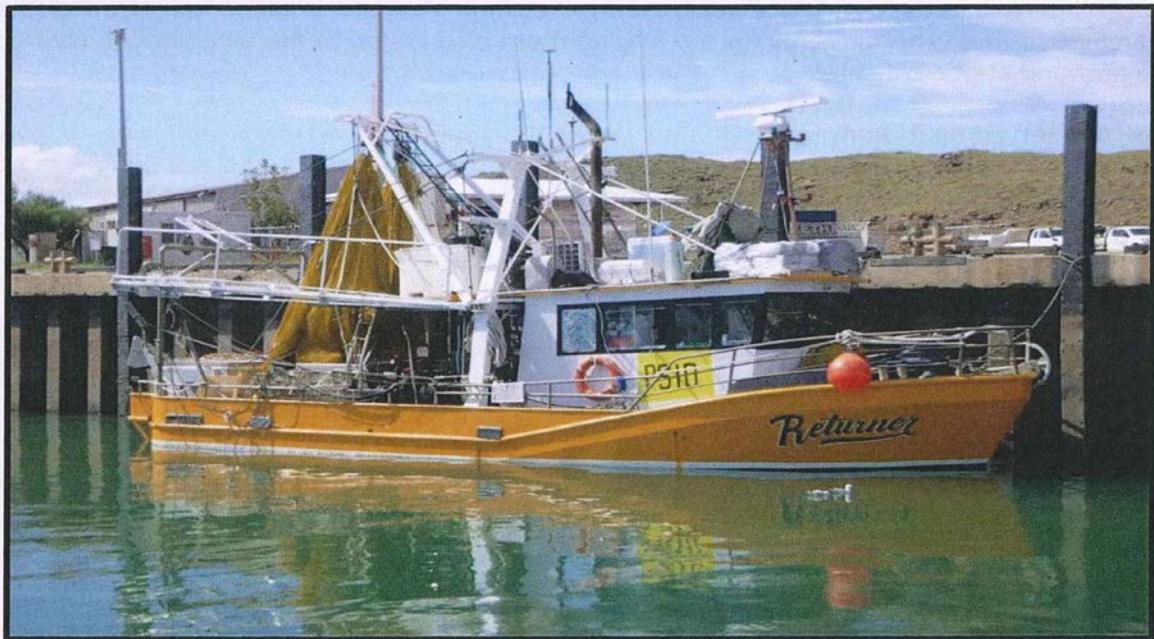
Photo 2 –Vessel after modifications in April 2015

41. The police investigation found no evidence to suggest the modifications or work undertaken on the *Returner* was inferior or of poor quality.<sup>44</sup> However, there was evidence that the overall effect of these extensive modifications

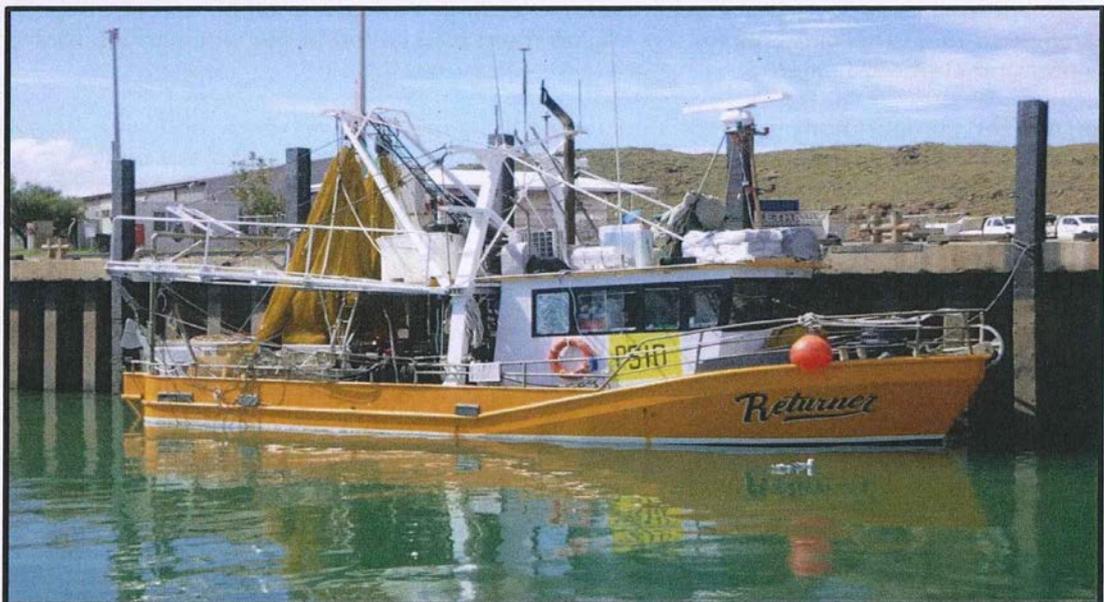
Photo 3 –Vessel after modifications in April 2015

shows the vessel to be marginally deeper in the water than she was at the time of Mr Wren’s final inspection on 14 April 2015 in Geraldton.<sup>140</sup>

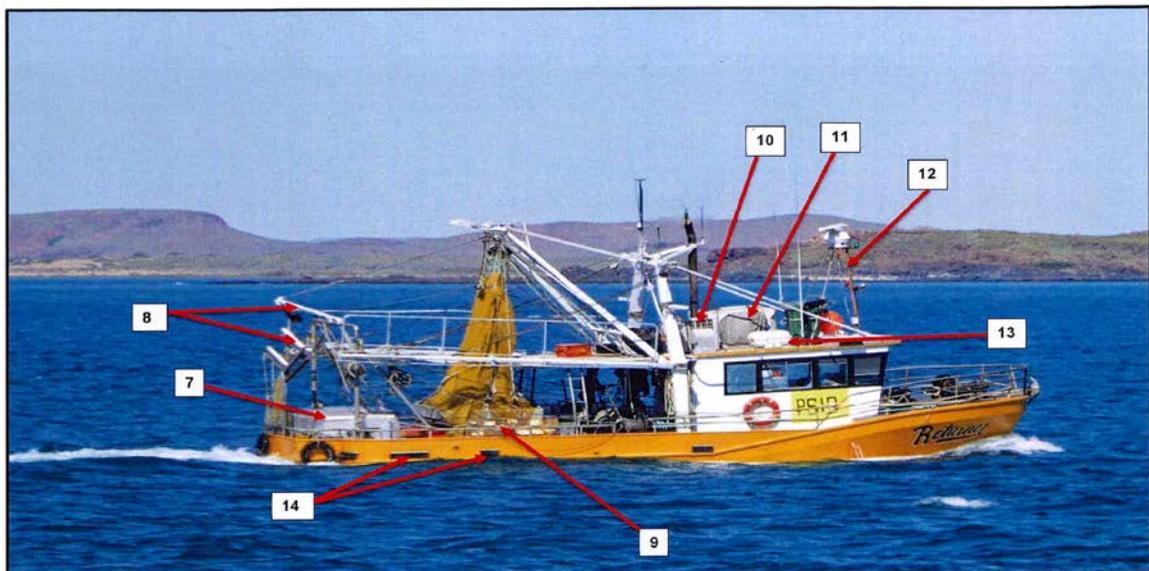
Photo 4 - Returner on Voyage Post 2014/2015 Modifications

108. A further photograph, which is depicted below, caused Mr Wren greater concern. Mr Wren’s evidence was that the vessel depicted in that photograph “is very different to the vessel that [he] observed at survey” and in his opinion that photograph shows the vessel “to be grossly overloaded.” This is

*With or without reference to any stability book, the vessel in the photograph shows to be clearly unsafe and should not be operating in this way, with almost zero freeboard and the freeing ports covered. If presented to me in any way to this extreme, I would have had no hesitation in refusing completion of the survey until further extensive investigation into the displacement and stability of the vessel was satisfactorily completed. At the very least, this would include a full, new stability assessment and approval process. Being so extreme, the vessel would not in any way have been authorised to operate.*

1. Try net winch situated on aft of wheelhouse roof aft on centreline
2. Large box thought to be containing nets and chain situated on port side on wheelhouse roof (not found at time of salvage)
3. Two wheelie bins thought to be for garbage (not found at time of salvage)
4. Steel exhaust stack thought to be increased in height between 2014 and 2015
5. 30 horsepower outboard motor tied in rigging
6. Large nets increased in size from original vessel
7. 3000 litre brine tank, double the capacity of the original brine tank
8. Try-net rigging thought to be installed between 2014 and 2015
9. Four Otter boards, each weighing approximately 265 kilograms
10. Split system air-conditioning outdoor unit.
11. Washing machine (not found at time of salvage)
12. Radar mast moved forward from original 1985 configuration.
13. Liferaft weighing approximately 30 kilograms
14. Covered freeing ports

113. Also, Mr Wren's evidence was that at no stage during inspection of the vessel did he see the freeing ports covered, which he would definitely have noted when he was when looking at the freeboard through the apertures. Mr Wren's evidence was that if he had seen the freeing ports covered in that way, he would have added it as a deficiency to be rectified as he would be concerned that water on deck would be severely restricted from freeing itself overboard.<sup>149</sup>

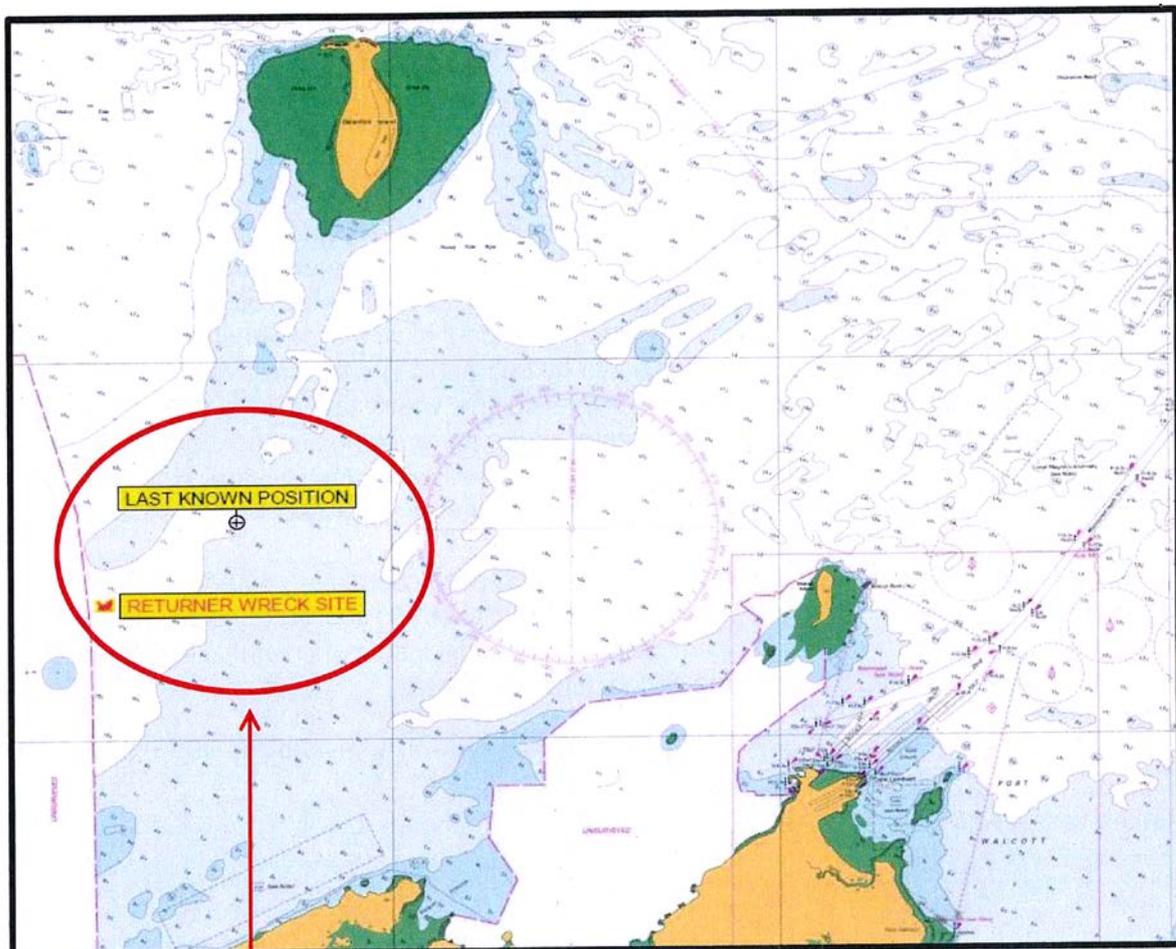
FIGURE 1 FROM REPORT IN Exhibit 1, Tab 11, p. 8

216. On Wednesday, 29 July 2015 the police vessel the *Delphinus* captured an image two kilometres south of the last known ALC coordinates of the *Returner*. The image was identified as the missing vessel *Returner*. The vessel was submerged in approximately 10 metres of water 20 km from Nickol Bay, Karratha.<sup>300</sup> The vessel was found approximately 1.9 nautical miles, or approximately 3.5 kilometres, from its last known position. When depicted on a chart, it can be seen that the vessel sank very close to its last known position.<sup>301</sup>
