RECORD OF INVESTIGATION INTO DEATH

Ref No: 41/15

*I, Evelyn Felicia Vicker, Deputy State Coroner, having investigated the death of **Susanne VAN DER SCHOOT**, with an Inquest held at Esperance Court House, 100 Dempster Street, Esperance, on 27 & 28 October 2015 find the identity of the deceased was **Susanne VAN DER SCHOOT** and that death occurred on 3 April 2012 at the intersection of the South Coast Highway and Murray Road, Dalyup, and was consistent with Multiple Injuries (external examination only) in the following circumstances:*

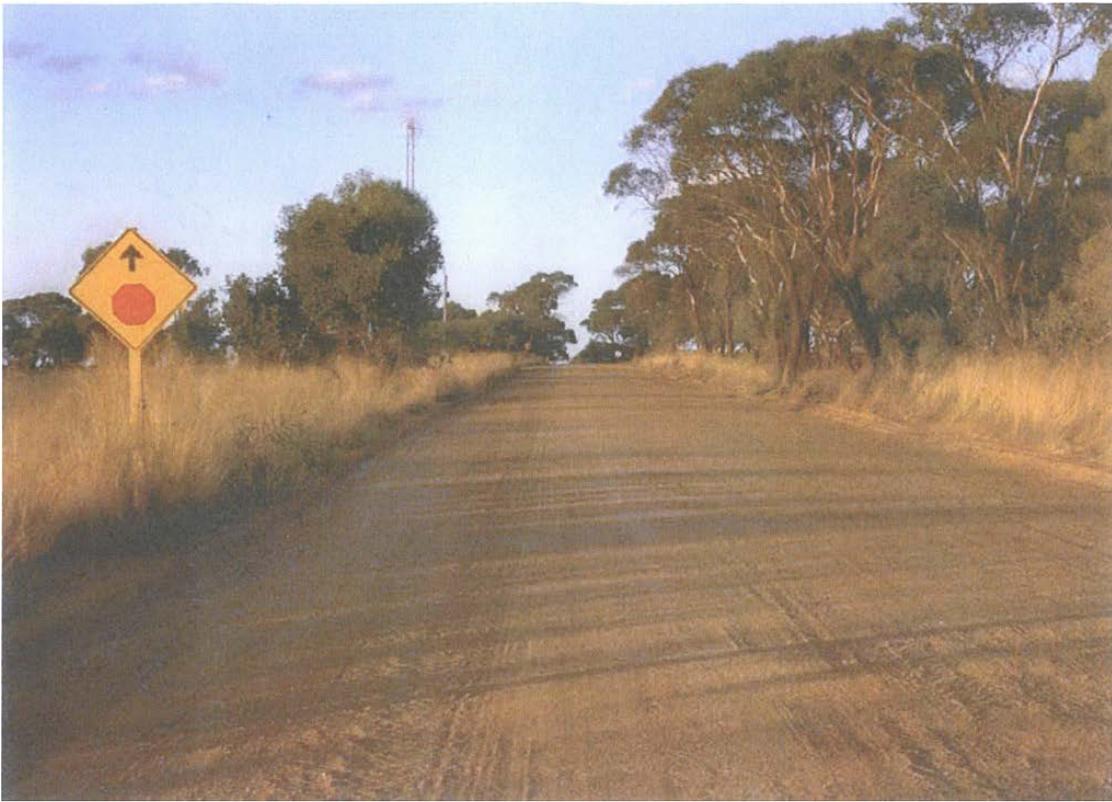
Exhibit 1, Tab 40, Photo 1

Approximately 240 metres before the intersection there was a warning sign advising traffic travelling towards the Highway there is a stop sign ahead. The warning sign was on the left hand verge and was clearly visible from some distance down Murray Road.²⁵

The sign was the recognised regulatory warning advisory sign for a stop sign but was smaller than those used currently. It was clearly visible and located before the incline towards the intersection. Given Ms Huiskamp had, within the last 40 minutes, left the Highway to approach the winery, the sign should have been a clear indication there was an intersection with the Highway approaching.
