RECORD OF INVESTIGATION INTO DEATH

Ref: 43/17

I, Sarah Helen Linton, Coroner, having investigated the suspected death of **Rohan Daniel WILSON** with an inquest held at the **Perth Coroner's Court, Court 51, CLC Building, 501 Hay Street, Perth** on **15 November 2017** find that the death of **Rohan Daniel WILSON** has been established beyond all reasonable doubt and that the identity of the deceased person was **Rohan Daniel WILSON** and that death occurred on or about **15 June 2016 at sea approximately 30 nautical miles from the coastline of Perth, in the vicinity of Mindarie Marina**, as a result of an **unascertained cause** in the following circumstances:

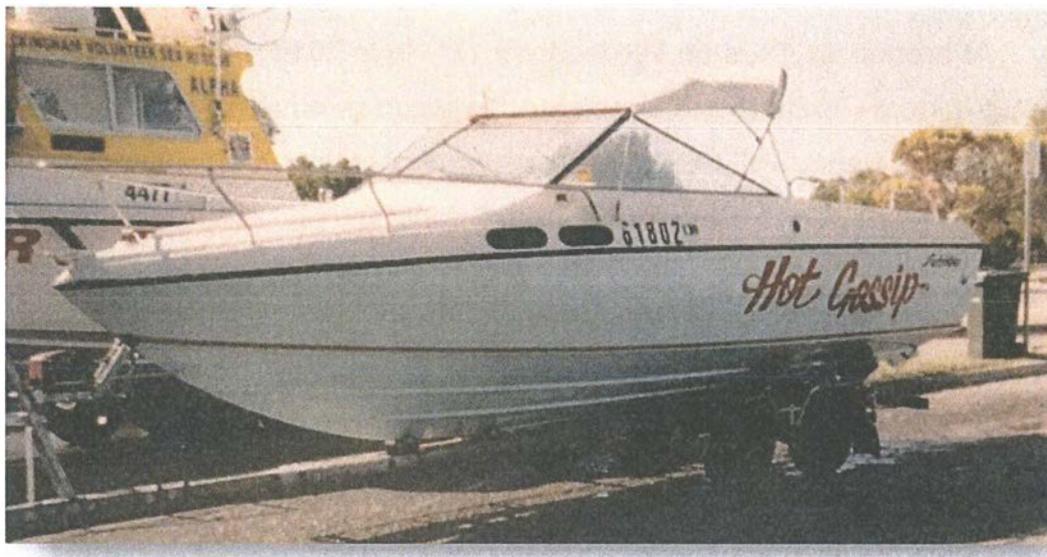
9. Mr Wilson was 38 years old in June 2016. He was married with two young children. He worked as a Production Chemist at Barrow Island on a 'fly in, fly out' basis.² He enjoyed his work.³
10. Mr Wilson owned a 6.4 metre registered power boat, which was named 'Hot Gossip'. It had an inboard petrol motor.⁴

Fig 3.1 -Photo of vessel 61802 'Hot Gossip'

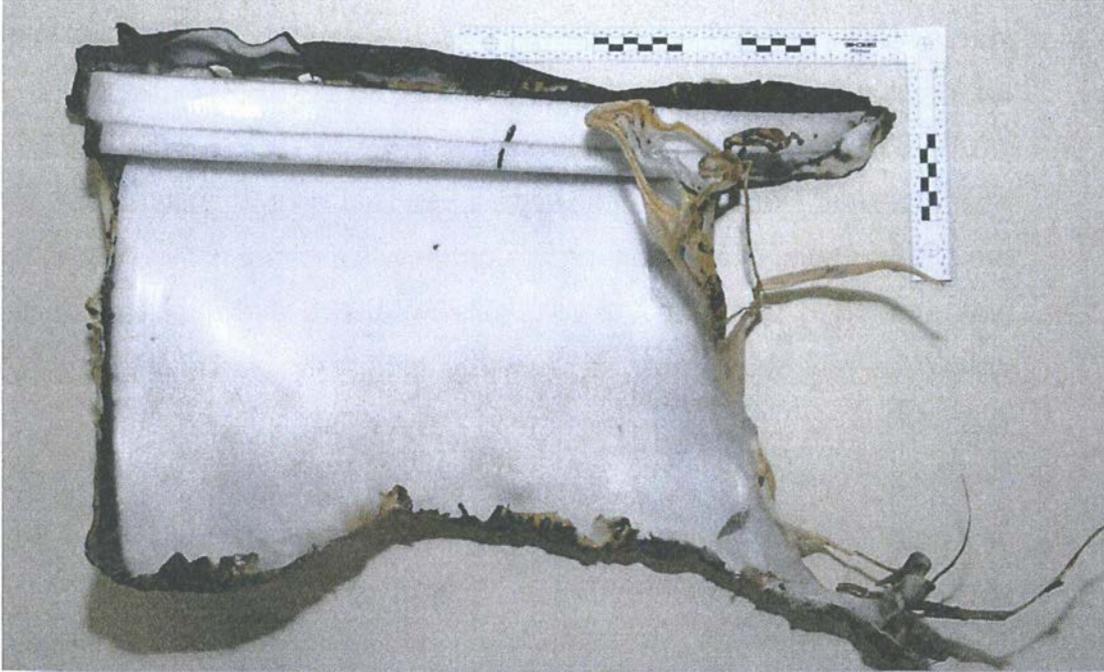
33. During search operations on 17 June 2016 vessel crews located and collected various items of flotsam and debris. Most were subsequently discounted as being related to Mr Wilson but of note was a small piece of white plastic located by one crew in the southern end of search area 2. It was noted to be in similar shape and appearance to a white plastic ice-box or Esky seen in photographs of the vessel provided by Mr Wilson's wife. The location of the burnt plastic piece was concurrent with drift modelling from the last known position of Mr Wilson's vessel.

Fig 6.4 – Police photograph of burnt piece of plastic located in search area 2 by VMR vessel Sea Guardian II

34. The finding of the burnt plastic piece significantly increased Senior Constable Cranshaw's suspicion of the possibility that the missing vessel had suffered either a catastrophic fire or an explosion.
35. Even though the time frame of survival had expired, further searching was planned for 18 June 2015, with a new search area re-calculated based on SARMAP drift models. Marine vessels were deployed to the location that the burnt plastic had been located. During this search some small items of

38. The search operation had attracted significant media coverage, which resulted in police receiving numerous calls from members of the public over the following weeks who had located items of possible interest on the beaches of Perth's northern suburbs. Based upon the information provided many of the items were seized and examined. After conducting enquiries with family members or relevant experts none of the items could be conclusively linked to the missing vessel,³⁶ although there was a strong inference that the burnt piece of plastic came from the white esky on board.³⁷

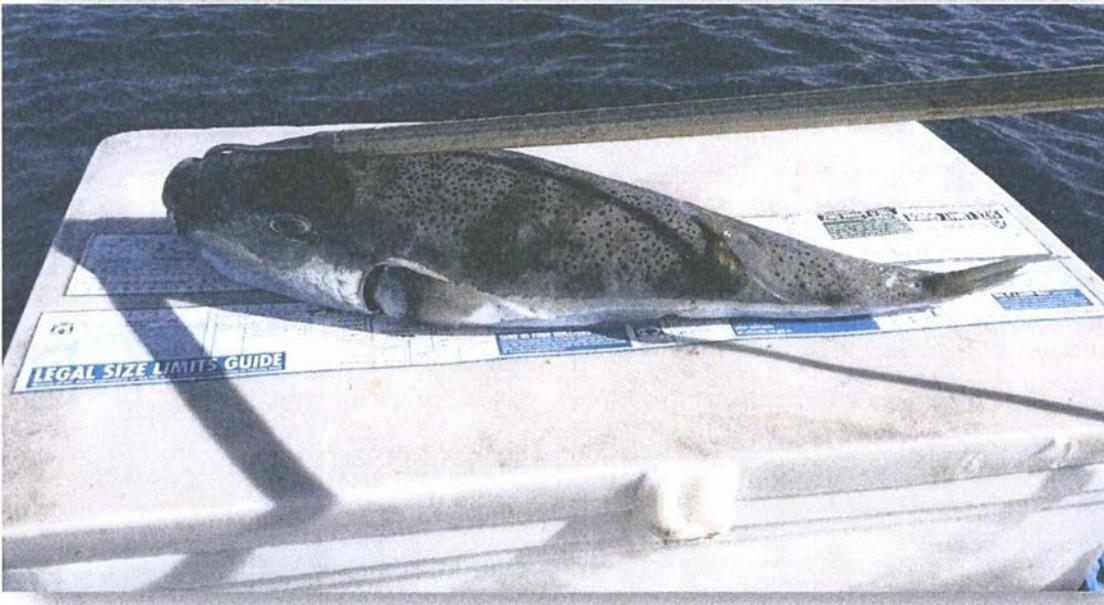
Fig 6.5 – Photograph supplied by Melissa WILSON showing plastic ice-box carried by her husband on the missing vessel
