RECORD OF INVESTIGATION INTO DEATH

Ref: 03/15

*I, Sarah Helen Linton, Coroner, having investigated the suspected death of **Samuel Eya LEOPOLDO** with an inquest held at the **Perth Coroner's Court, Court 51, CLC Building, 501 Hay Street, Perth, on 23 January 2015** find that the death of **Samuel Eya LEOPOLDO** has been established beyond all reasonable doubt, that the identity of the deceased person was **Samuel Eya LEOPOLDO** and that death occurred on or about **17 November 2011 in sea, approximately three nautical miles west of Rottnest Island off the port of Fremantle, Western Australia (Latitude 32° 00.85' South, Longitude 115° 23.95' East)** in the following circumstances -*

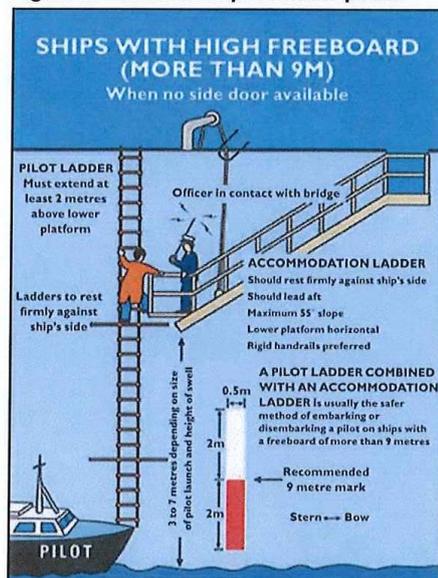
Figure 2 - Combination Ladder

28. Sometime after 11.00 am, the bosun of the ship, Mr Edgardo Eran, began to prepare the combination accommodation and pilot ladder with Mr Leopoldo and two other crew members, Ordinary Seaman Jake Lorenana and Deck Cadet Zammy Millare. The ladder was positioned amidships on the port side of the ship, with its lowest step intended to be 2.5 metres above the waterline, as part of the normal operating procedures.³³ Mr Leopoldo was assigned the task of going down the combination ladder over the side of the ship to secure the accommodation and pilot ladder.³⁴
