## RECORD OF INVESTIGATION INTO DEATH

*Ref No: 33/13*

*I, Dominic Hugh Mulligan, Coroner, having investigated the death of **Barkad Ahmed Muse**, with an Inquest held at Albany Coroners Court on 25 July 2013, and Perth Coroners Court on 29 July & 19 - 23 August 2013, find that the identity of the deceased person was **Barkad Ahmed Muse** and that death occurred on 20 July 2012, at 282 Middleton Road, Centennial Park, Albany, as a result of **Crush Asphyxiation**, in the following circumstances;*

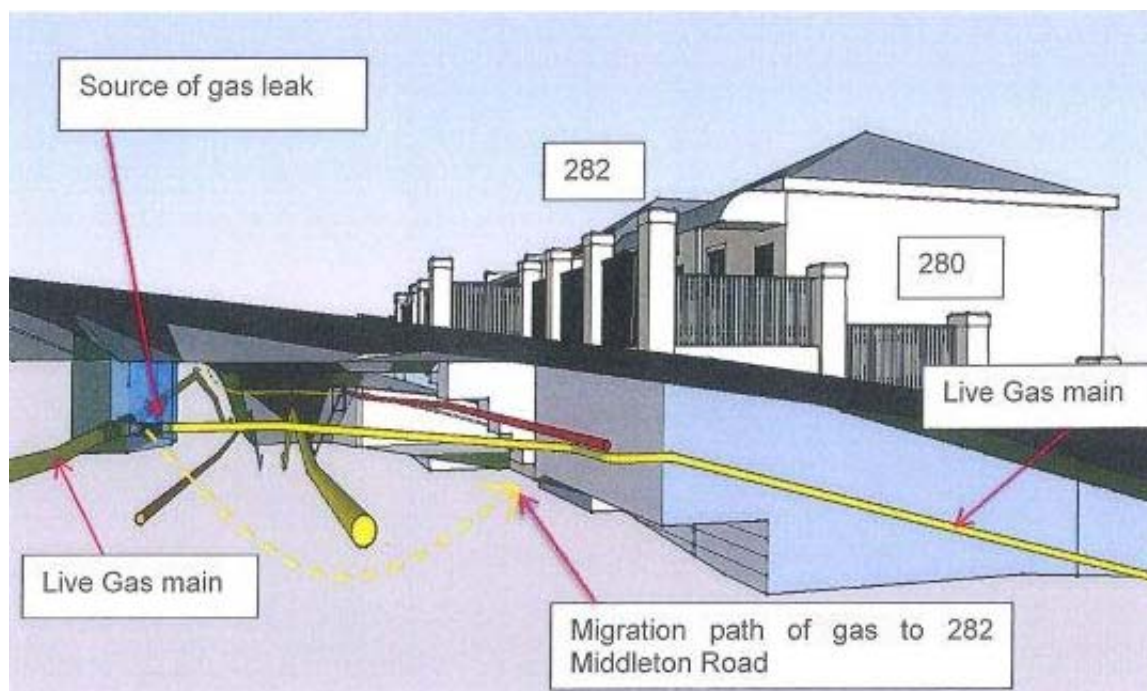
Exhibit 1, Volume 2, Tab 55, Page 15

25. The gas which pooled under the bedroom Ms Muse Farah shared with her two nieces came from a gas main located about 15 metres away. At that location the 155mm gas main which ran along the southern verge of Middleton Road connected with an 80mm gas main which ran at 90° to the Middleton Road main, and travelled down Douglas Street.
26. The gas leak came from a device known as a Stockbrands Compression Coupling (SBCC), a device used to connect two pieces of the 80mm uPVC gas mains that ran from Middleton Road down Douglas Street. The leak occurred very close to the 155mm main that ran along Middleton Road.

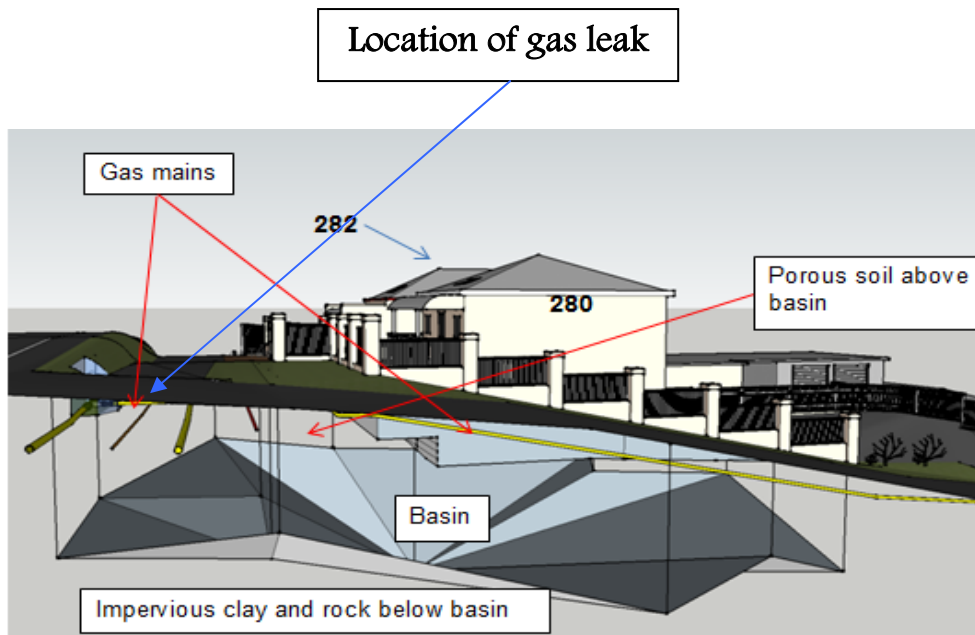
Exhibit 1, Volume 2, Tab 55, Page 14

53. The SBCC remained undisturbed and apparently leak free until sometime after leaks were repaired near to the SBCC in February 2012.
54. On 13 September 2011 a gas leak was detected near the gas main above 280 Middleton Road.<sup>3</sup>
