RECORD OF INVESTIGATION INTO DEATH

Ref No: 41/15

*I, Evelyn Felicia Vicker, Deputy State Coroner, having investigated the death of **Susanne VAN DER SCHOOT**, with an Inquest held at Esperance Court House, 100 Dempster Street, Esperance, on 27 & 28 October 2015 find the identity of the deceased was **Susanne VAN DER SCHOOT** and that death occurred on 3 April 2012 at the intersection of the South Coast Highway and Murray Road, Dalyup, and was consistent with Multiple Injuries (external examination only) in the following circumstances:*

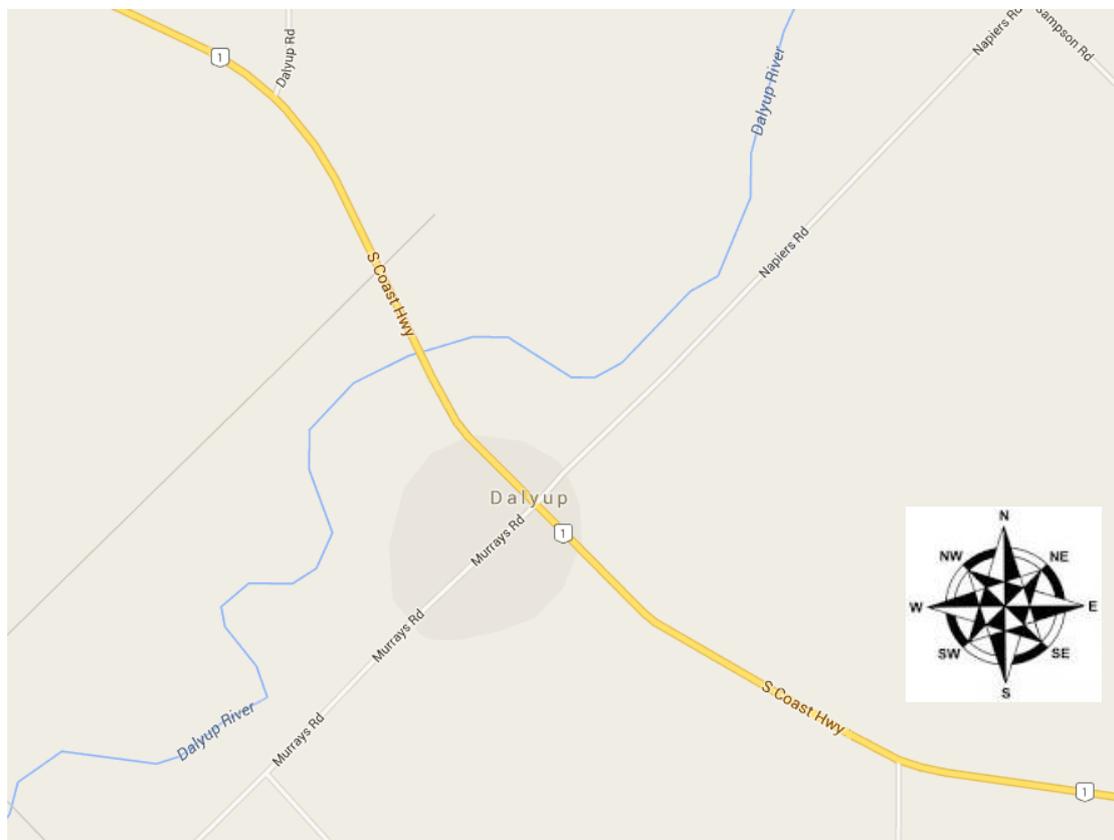
Google Map

Lines of sight for all drivers approaching the intersection from any direction were restricted, including those drivers on the Highway where the road conditions would encourage drivers to assume the state default speed limit of 110 km/h

Main Roads refused the application request on the grounds the road was not suitable for that level of use, nor was the intersection with the Highway. The restricted visibility at the intersection raised a real concern slow turning trucks, out of Murray Road onto the Highway, would create a hazard for vehicles on the Highway.
