Western

RECORD OF INVESTIGATION INTO DEATH

Ref No: 5002/11

I, Kevin TAVENER, Coroner, having investigated the death of **Anthony John BRADANOVICH**, with an Inquest held at Perth Coroners Court on 3 August 2012 and 6 & 7 September 2012 find that the identity of the deceased person was **Anthony John BRADANOVICH** and that the death occurred on 23 January 2011 at Wiluna as a result of exertional heat stroke in the following circumstances –

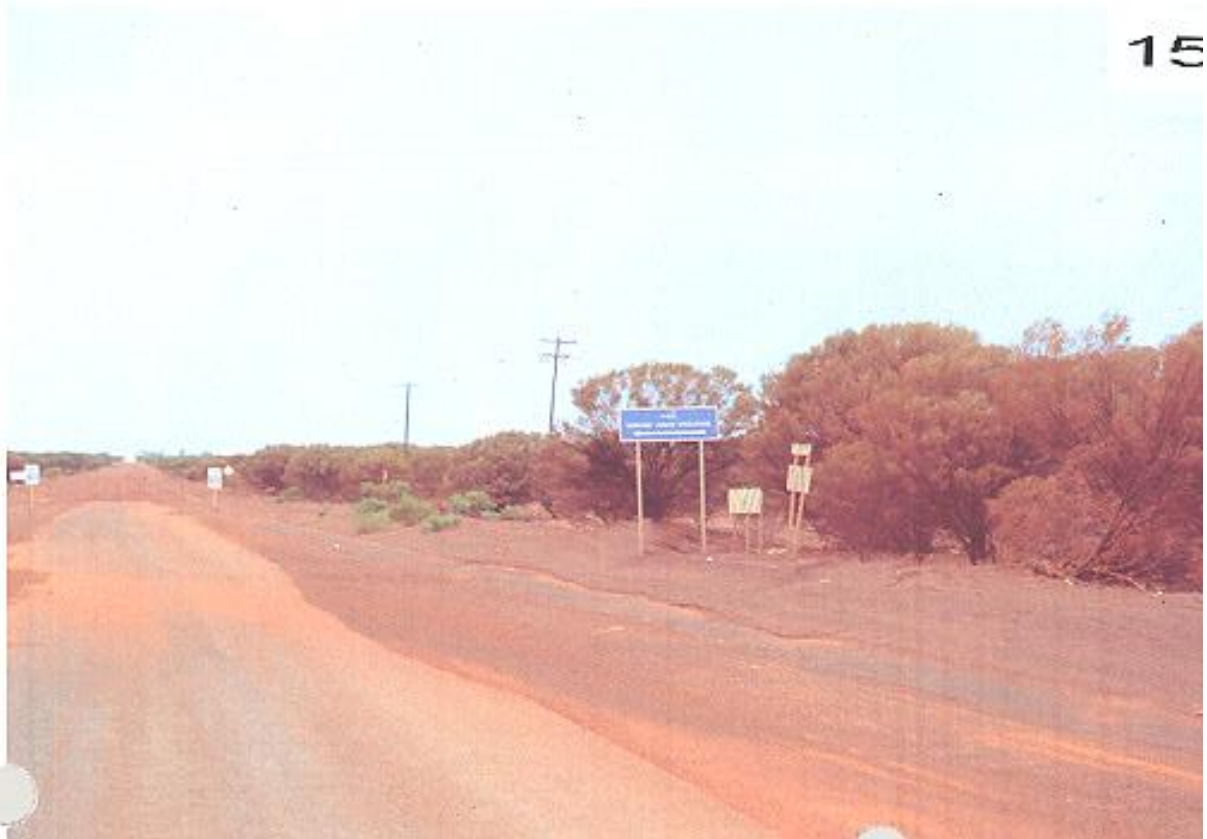
Figure 3 : Exhibit "1" tab 61 no. 15 depicts the blue signage erected by the Council along the Gunbarrel Highway directing traffic towards the Jundee mine site

An application to Wiluna Council to install a sign 1800mm x 600mm, directing traffic towards the Jundee mine site along the Gunbarrel Highway was approved by the Council on 21 August 2008.¹²⁸ The sign was installed in the dimensions approved, and is the blue sign depicted in Figures 3 and 4, above.¹²⁹

Given that the terrain is flat and there is no other signage in the immediate vicinity indicating another turn off and with nothing obstructing the three signs, it could not be said the signs (when examined in context) were “unclear”, particularly if observed during daylight hours.

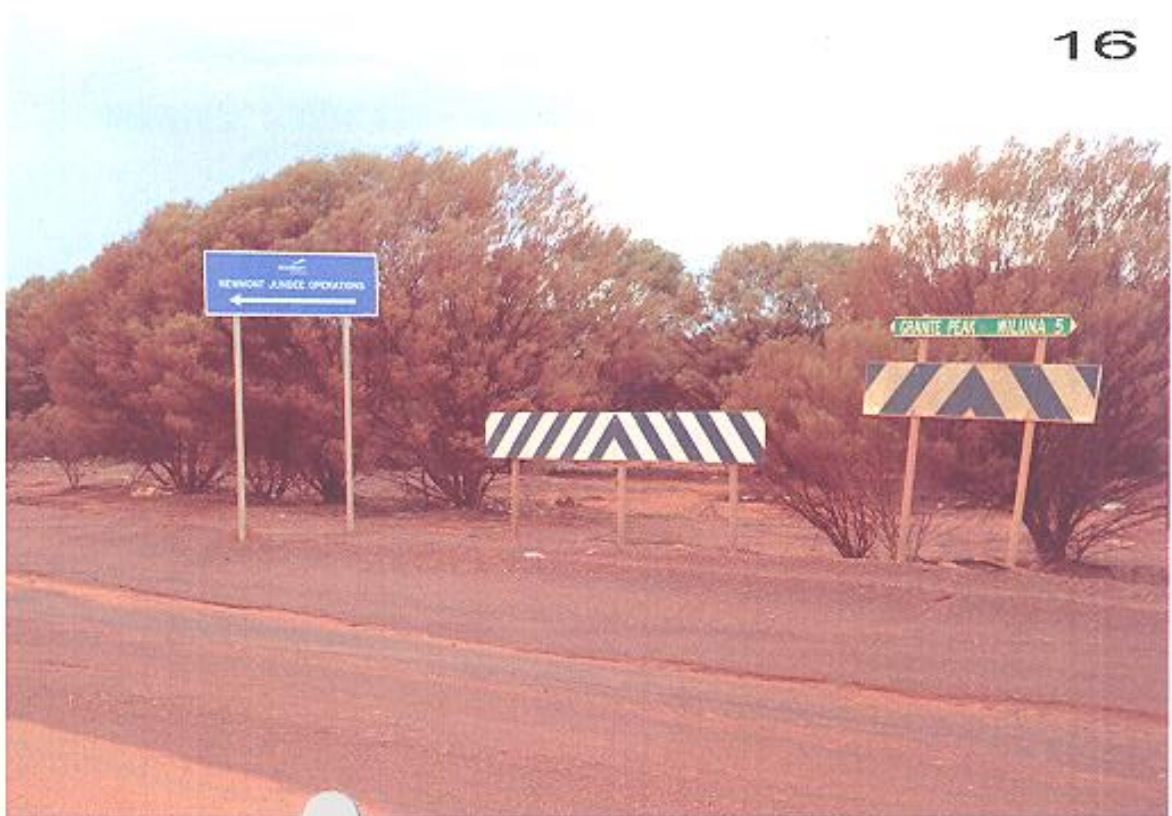
Figure 4 : Exhibit "1" tab 61 no. 16 depicts the blue signage erected by the Council along the Gunbarrel Highway directing traffic towards the Jundee mine site

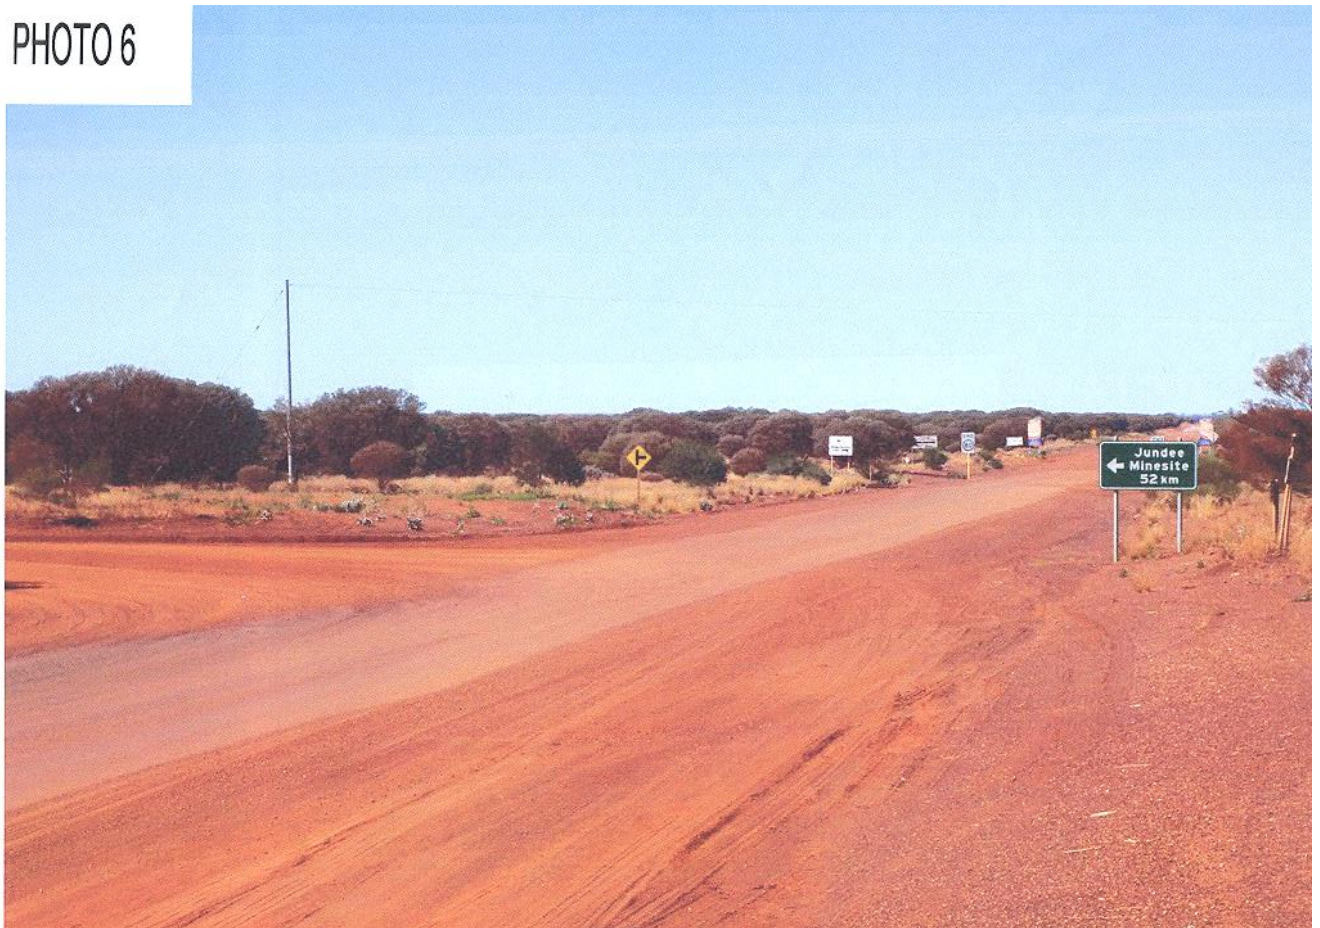
Figure 5 : Exhibit "2" tab 62 no. 6 depicts the end of the bitumen road surface just past the 80km/h road sign and turn off to the Jundee mine site

Subsequent to the deceased's death the signs directing traffic to the Jundee mine site have been changed. On the evidence before the Court, the change was instigated by Newmont Mining in January 2011 and was approved by Council the same day.¹³⁰ The blue sign that was on the right hand side of the road has been replaced by a larger more traditional looking green sign, which clearly reads "Jundee Mine site 52km".¹³¹

The new signage is an improvement.
